# PRESCOTT ENGINEERING, LLC

May 1, 2023

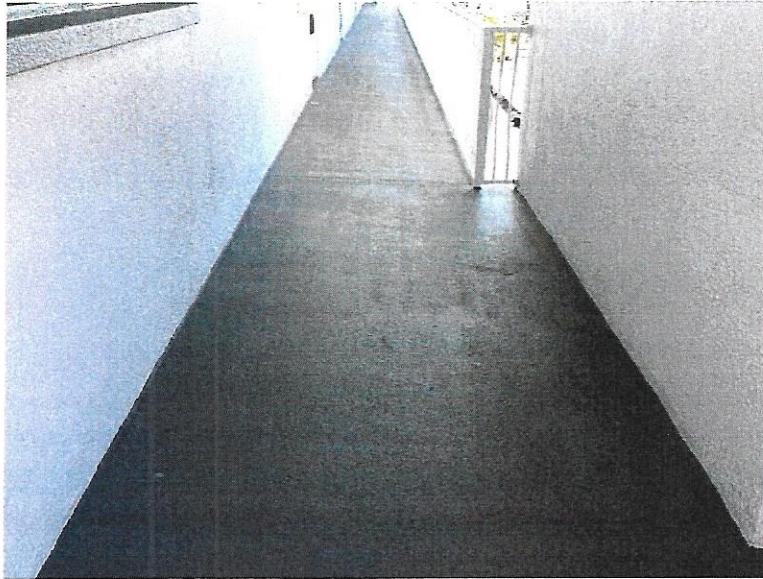
1. The walkways were observed to consist of a urethane coating. Refer to *Figure 1*.

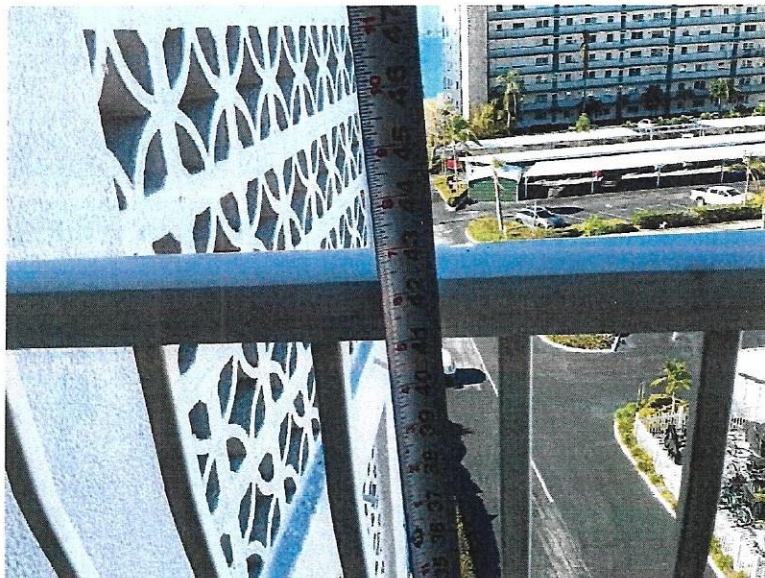
2. The railing of the walkways was found to be 42.5 inches in height, which is in compliance with the current building code. Refer to *Figure 2*.

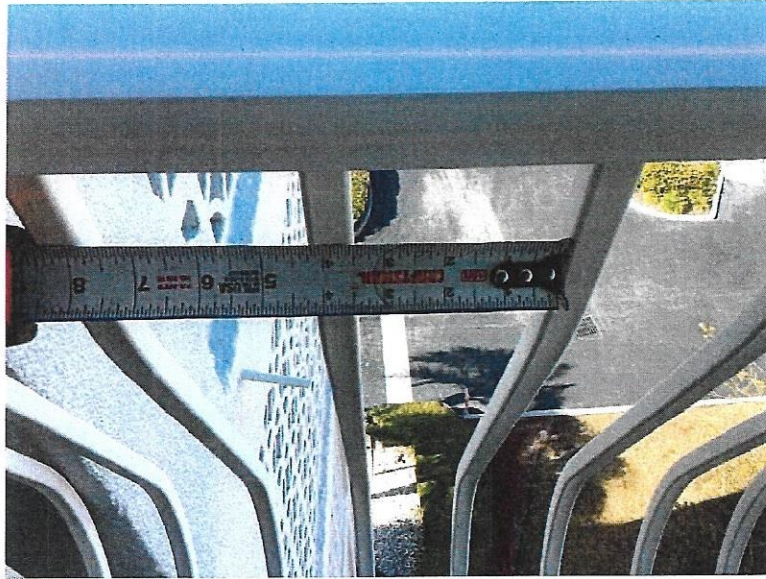
3. The clear opening between the pickets in the guardrail on the walkways was found to be 3.75 inches, which is in compliance with the current building code. Refer to *Figure 3*.

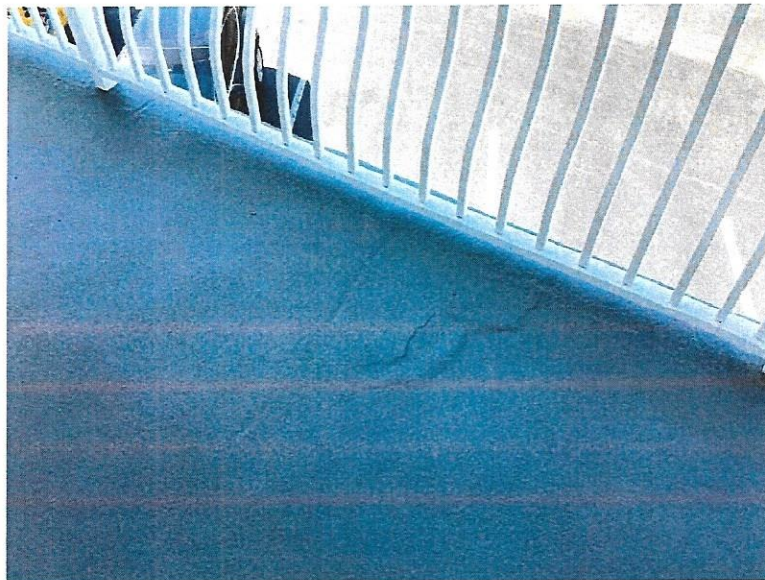
4. Some areas on the walkways evidenced open or previously repaired cracking. Refer to *Figure 4*.

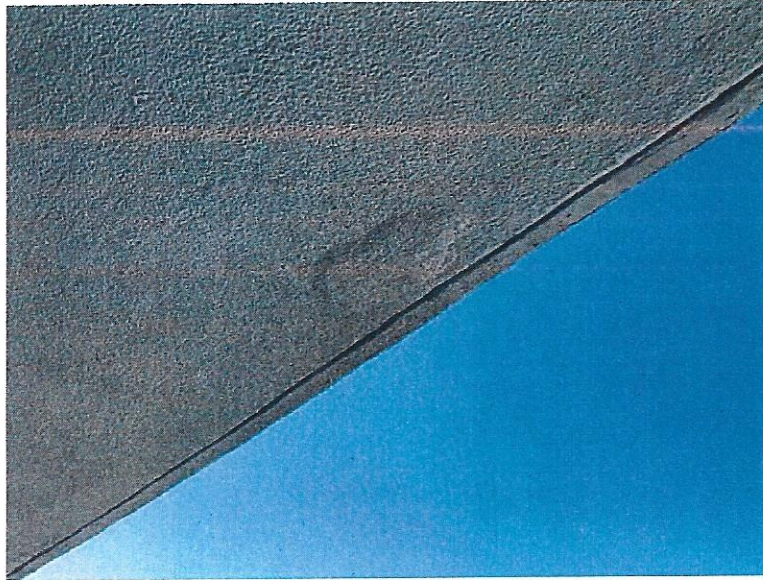
5. Some areas of the walkway ceilings evidenced visible spalling. Refer to *Figure 5*.

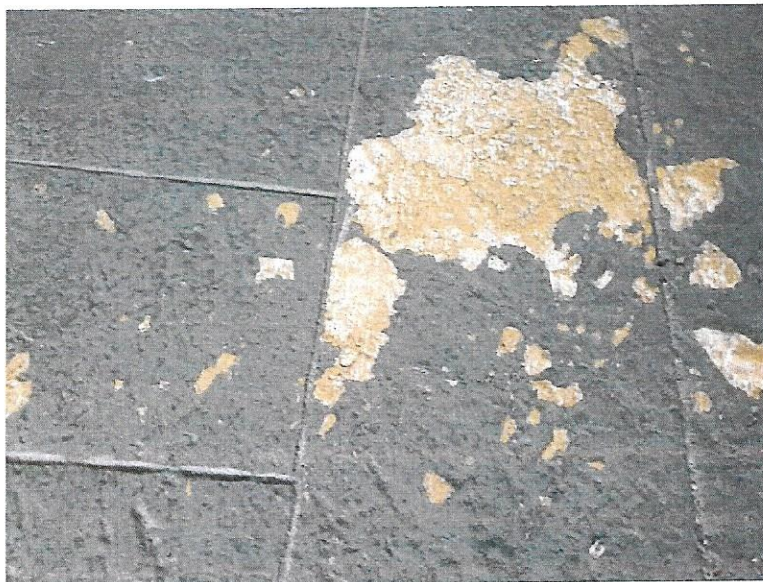
6. Some areas of the elevator landing stamped concrete coating evidenced failure. Refer to *Figure 6*.

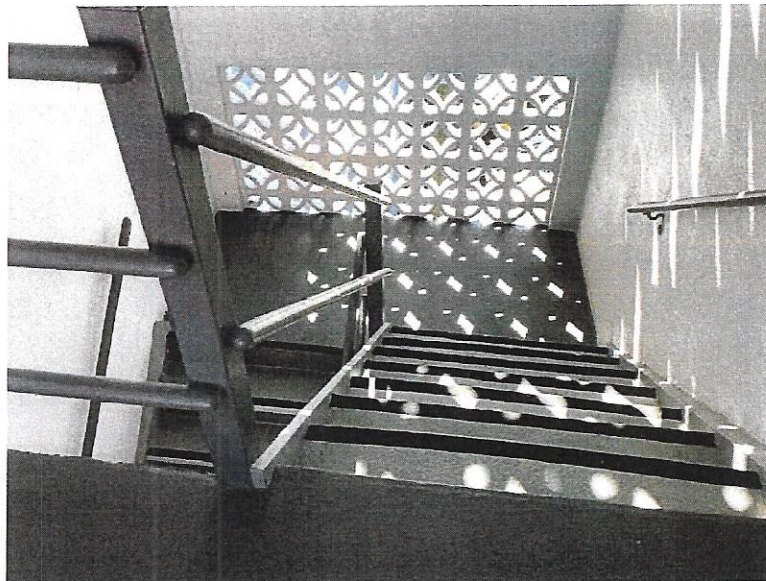
8. The stairs were observed to consist of a concrete stair system and concrete landings. Refer to *Figure 7*.

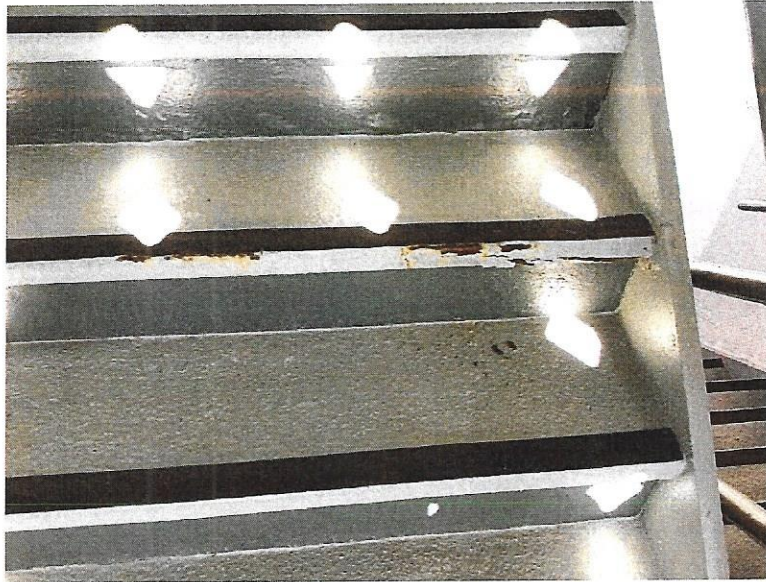
9. Several locations of corrosion and section loss were documented in the stairwells.  
Refer to *Figure 8* and *Figure 9*.

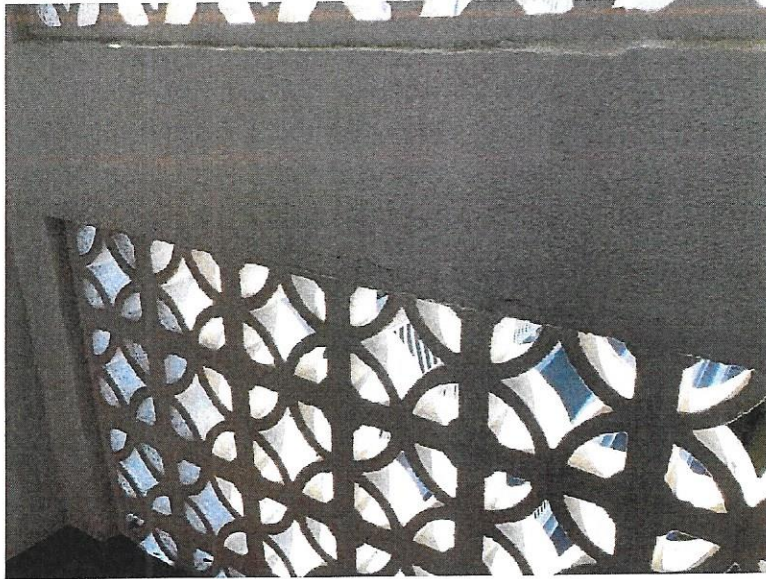
9. Portions of the stair walls were detected by mechanical sounding to have spalling present. Spalls were detected on the western stairwell in five locations, ranging in size from 1'x1' to 6'x8". Corrosion also was detected on 6 column posts of the west. Refer to *Figure 10*.

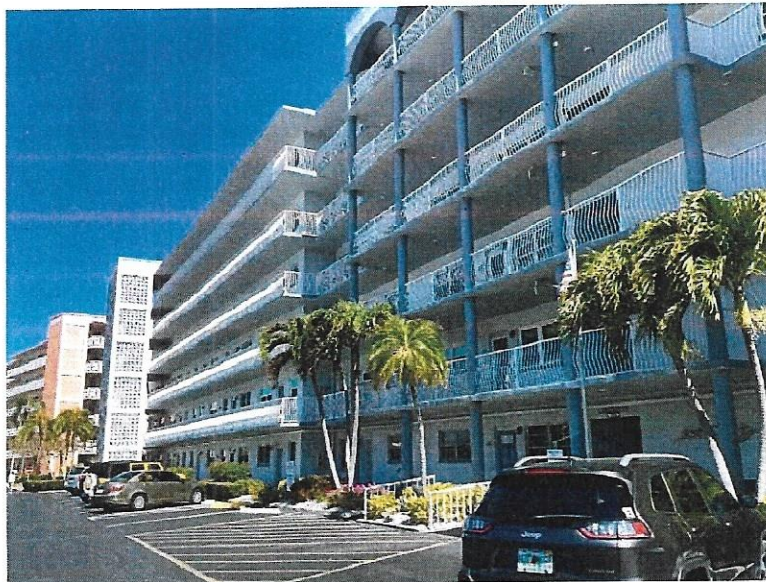
10. The majority of the exterior walls of the structure appeared to be stucco overtop concrete and/or concrete masonry units (CMU) in-fill walls. The exterior appeared to have been recently painted. No widespread cracking was observed within the majority of walls of the structures. Refer to *Figure 11*.

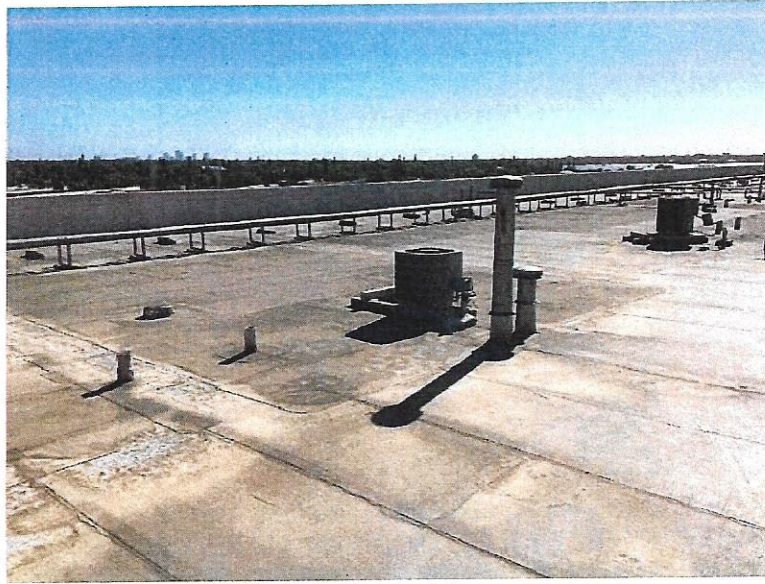
11. The roof was observed to consist of a built-up roof with silicone coating. Refer to *Figure 12*.

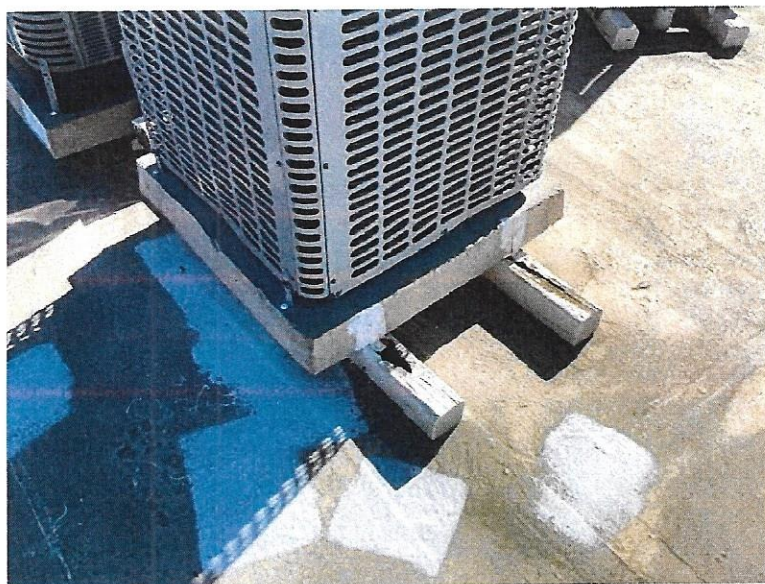
12. The rooftop air conditioning units were observed to be currently mounted on wooden sleepers. These do not meet current code requirements and will be required to be mounted on stands or curbs when the roof is replaced. Refer to *Figure 13*.

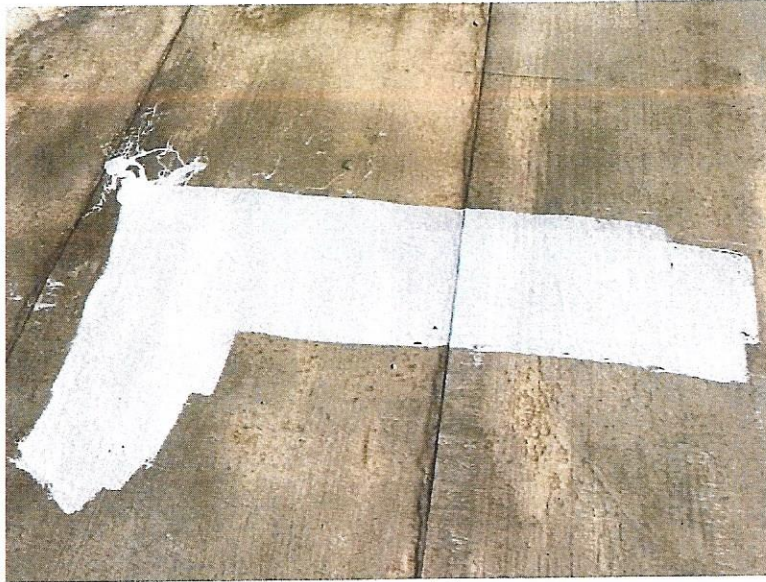
13. Numerous areas of previous repairs were identified. Refer to *Figure 14* and *Figure 15*.

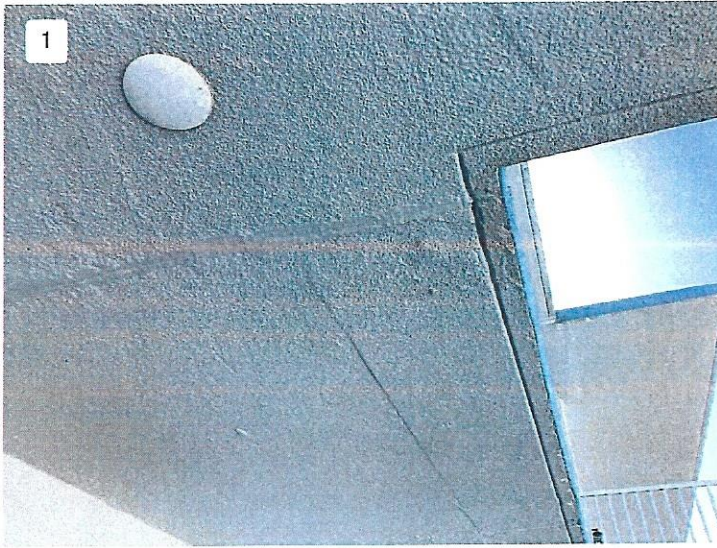
Previous overhead repair

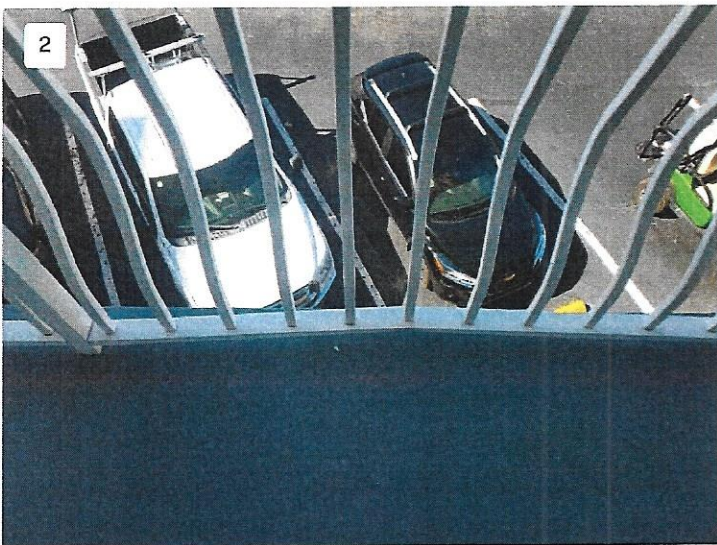
Project: Lancaster  
Date: 3/23/2023, 10:48am  
Creator: Clayton Prescott

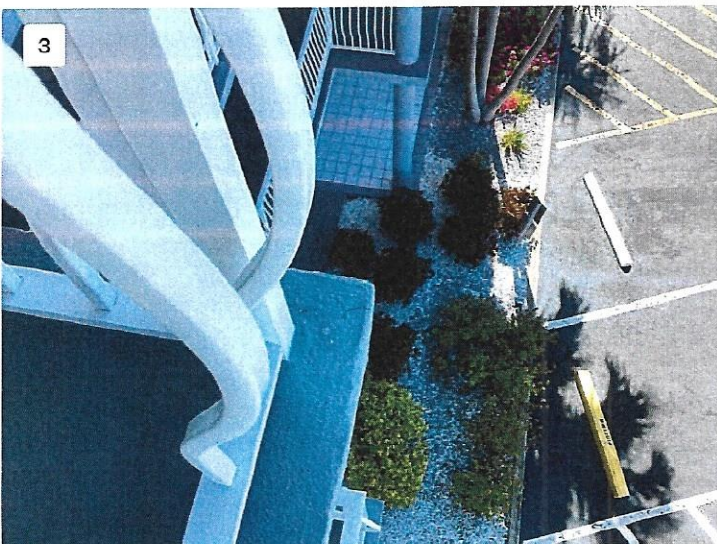
Crack in area of post pocket

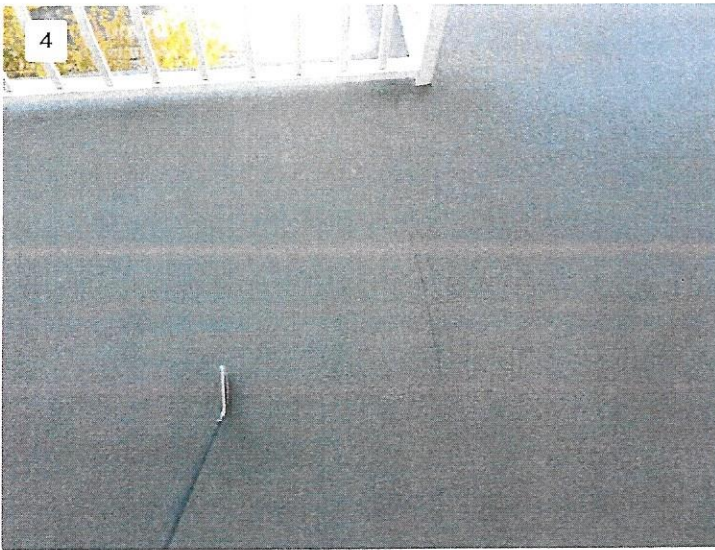
Crack in floor coating at joint

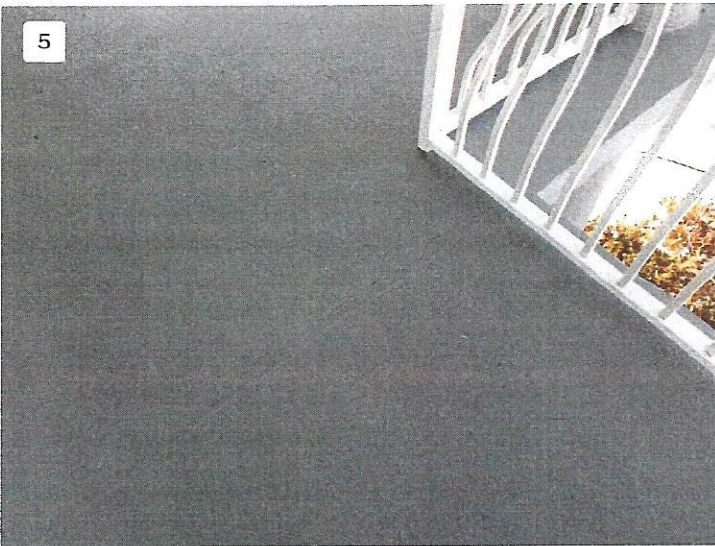
Crack in floor coating at joint

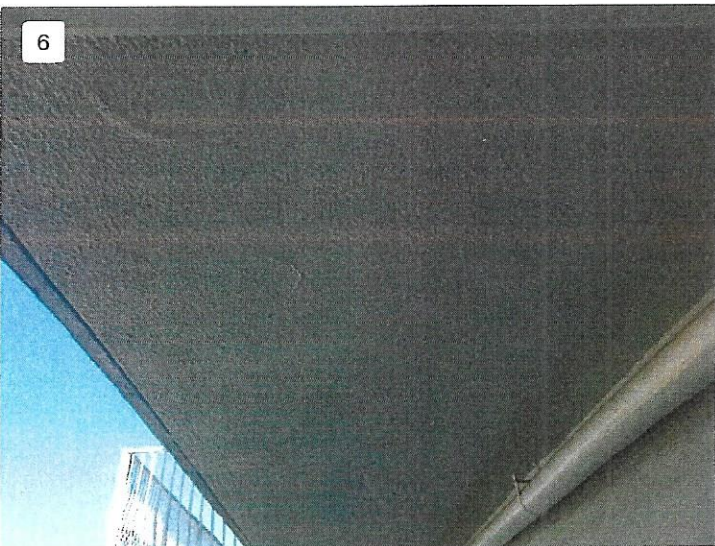
Paint blisters in ceiling

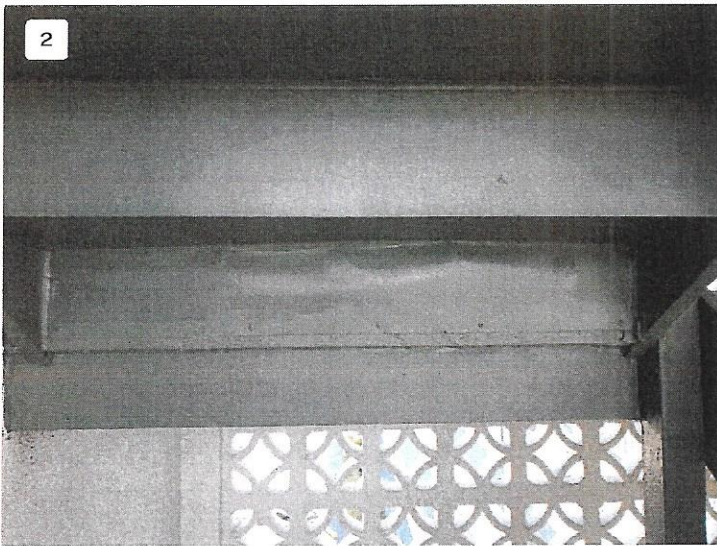
Bulging repair to rear of stair tread

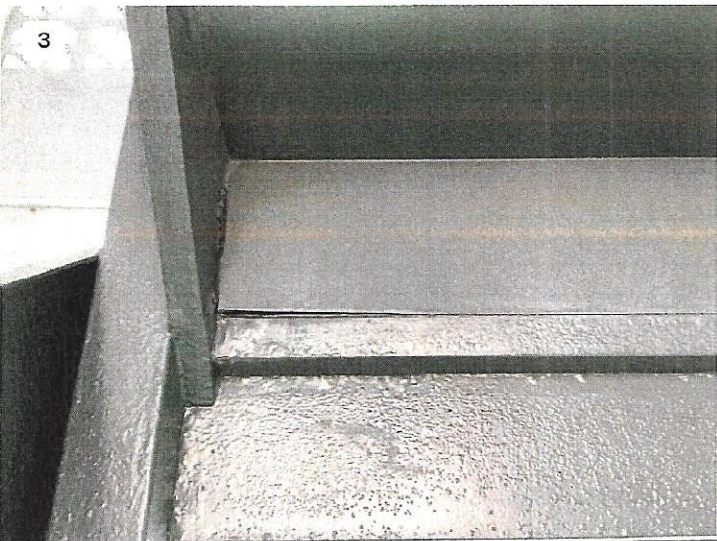
Previous repair of stair tread

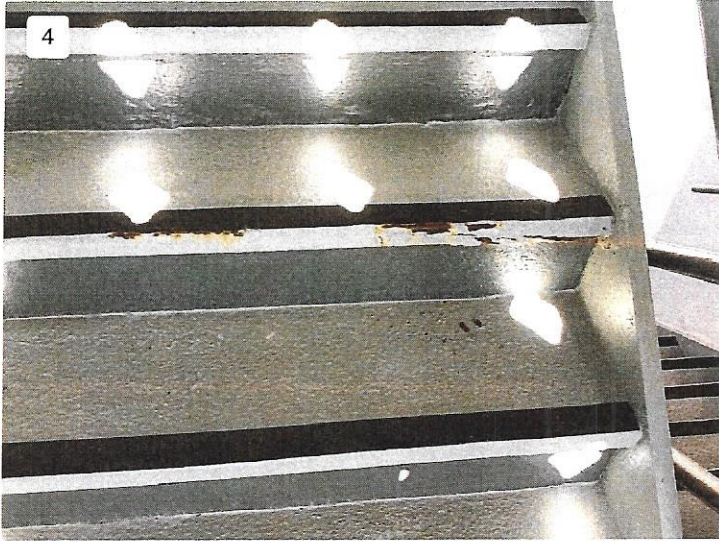
Corrosion of stair tread

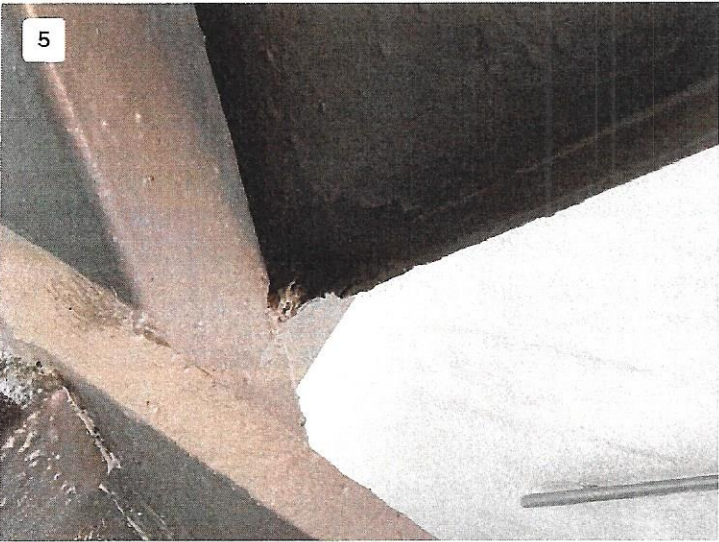
Corrosion of support post at landing connection

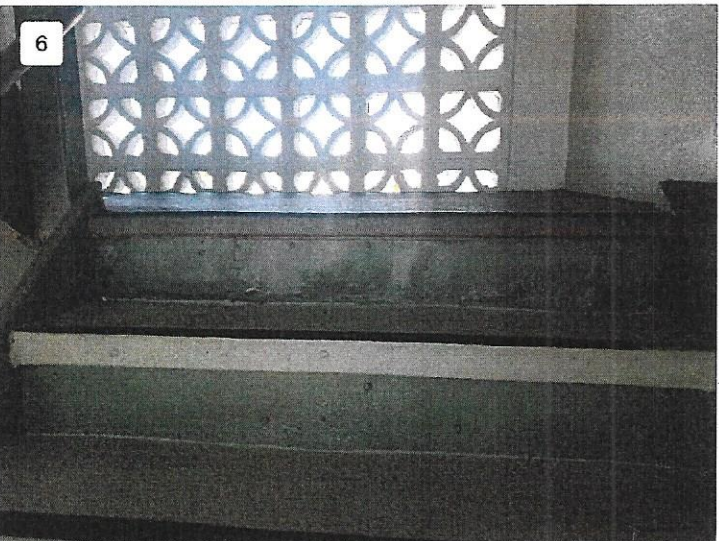
Project: Lancaster  
Date: 3/23/2023, 11:02am  
Creator: Clayton Prescott

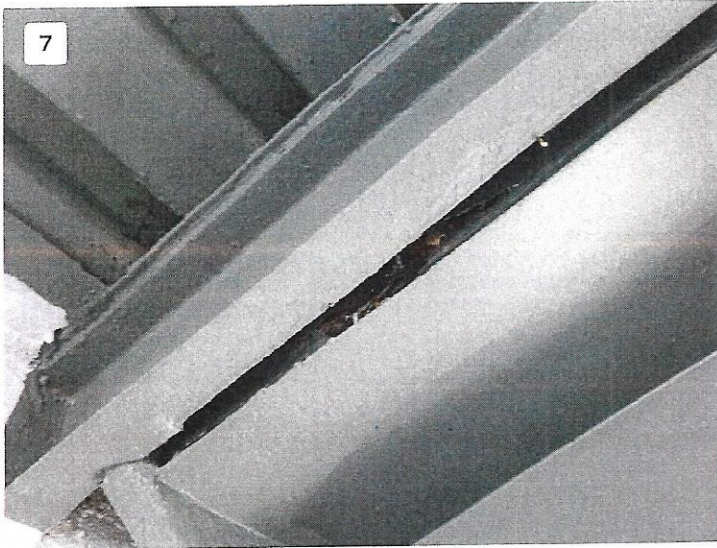
Corrosion of stair at landing

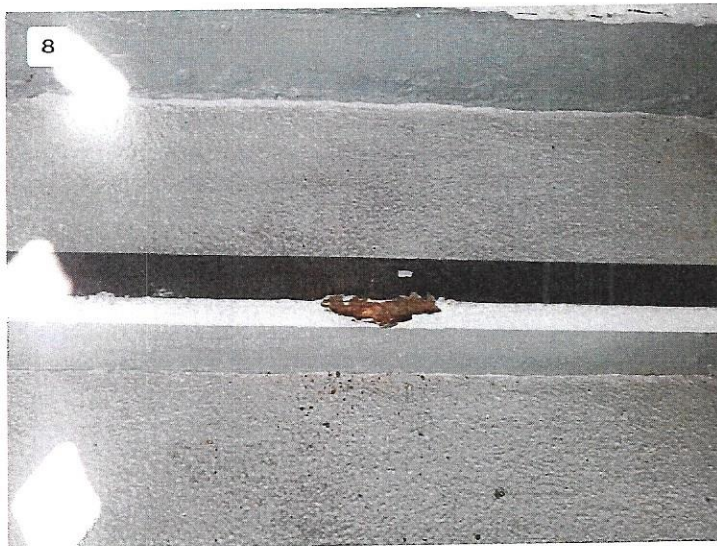
Project: Lancaster  
Date: 3/23/2023, 11:04am  
Creator: Teddy Watkins

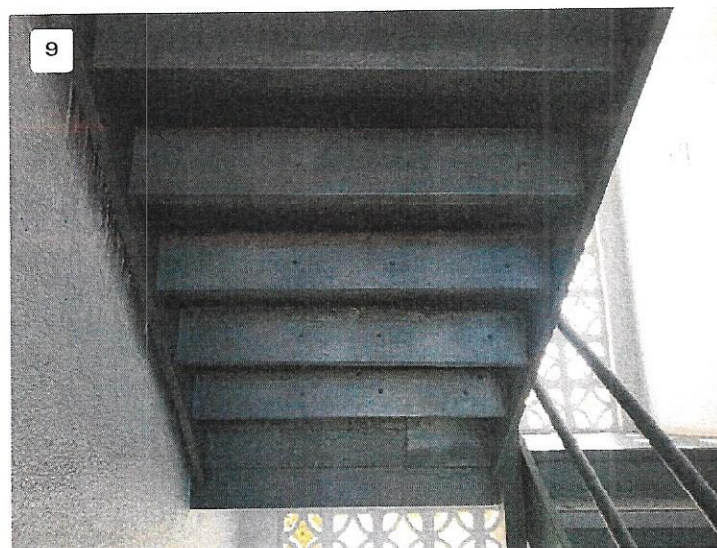
Previous metal repair to stair.

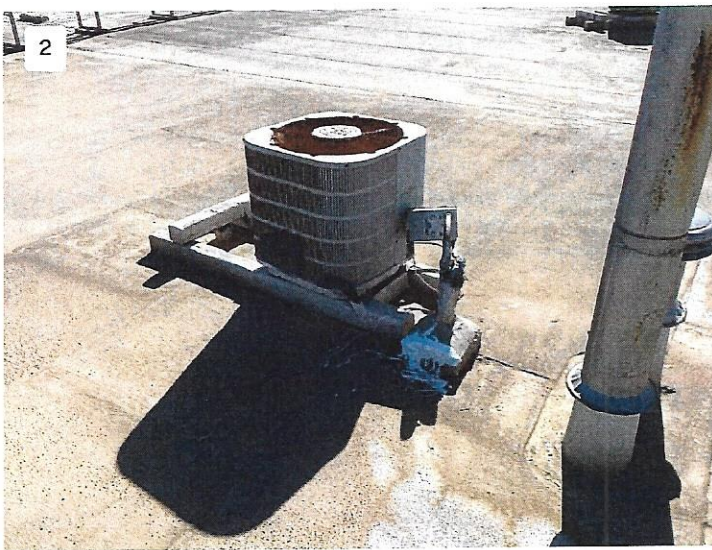
AC unit on sleepers directly on roof deck

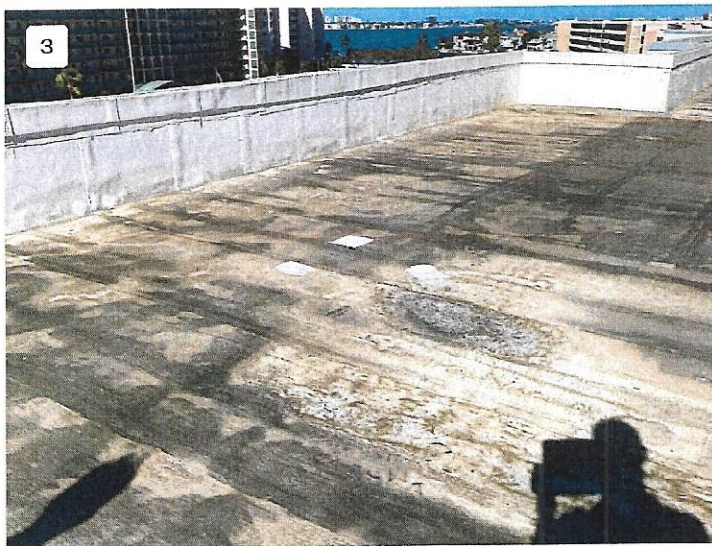
Project: Lancaster  
Date: 3/23/2023, 10:10am  
Creator: Clayton Prescott

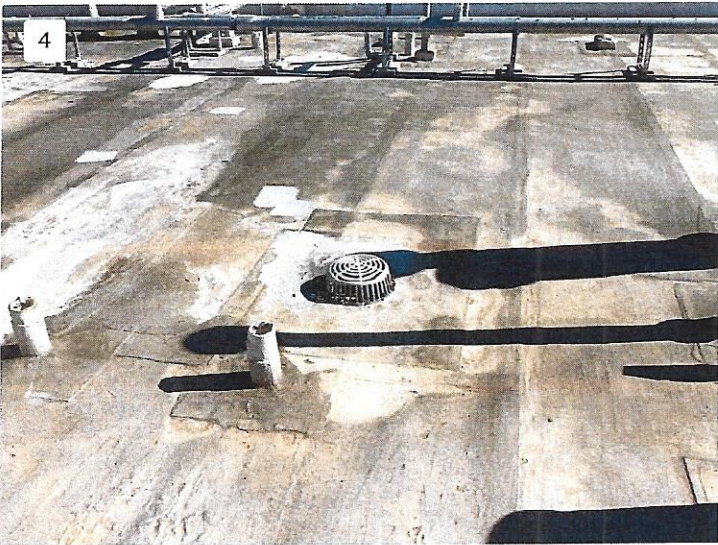
Project: Lancaster  
Date: 3/23/2023, 10:11am  
Creator: Clayton Prescott

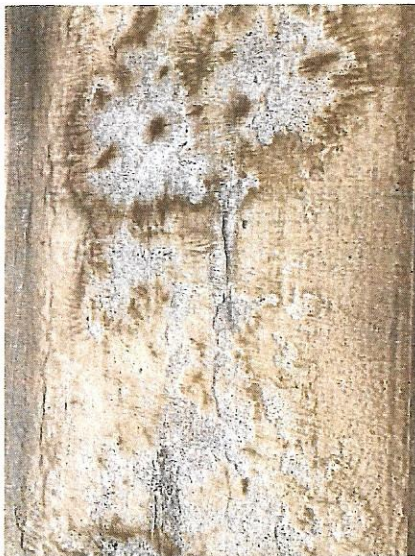
Closeup of roof coating condition

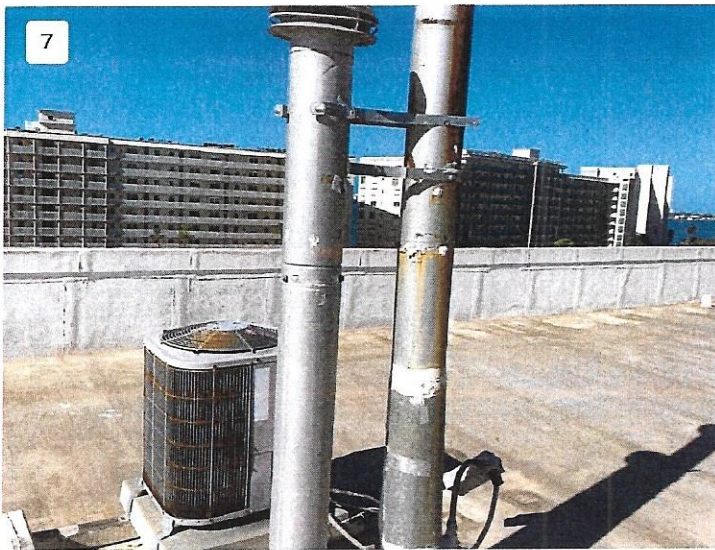
Repairs to vent stacks

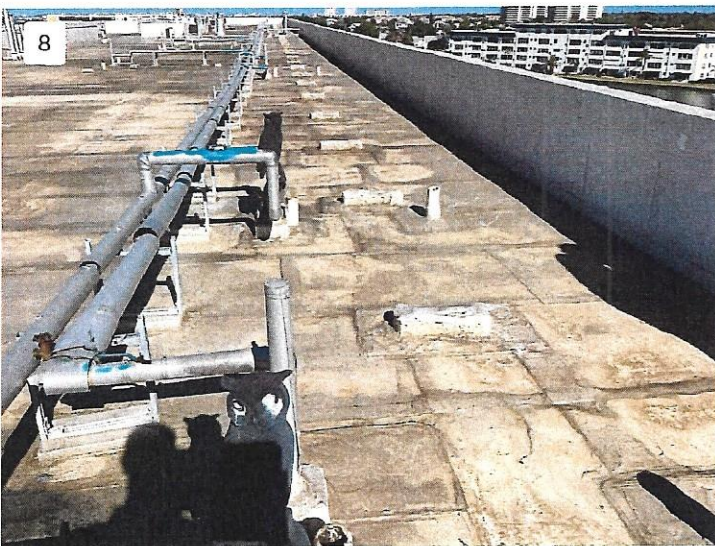
Piping and abandoned stands

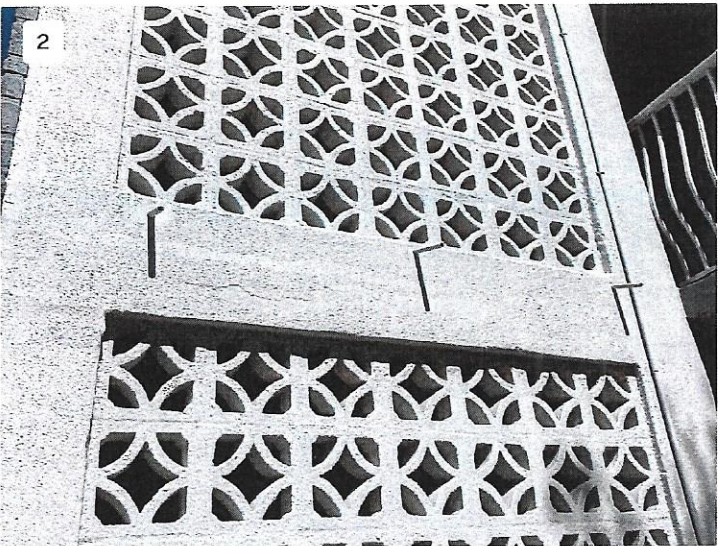
exterior of lintel spall in stairwell

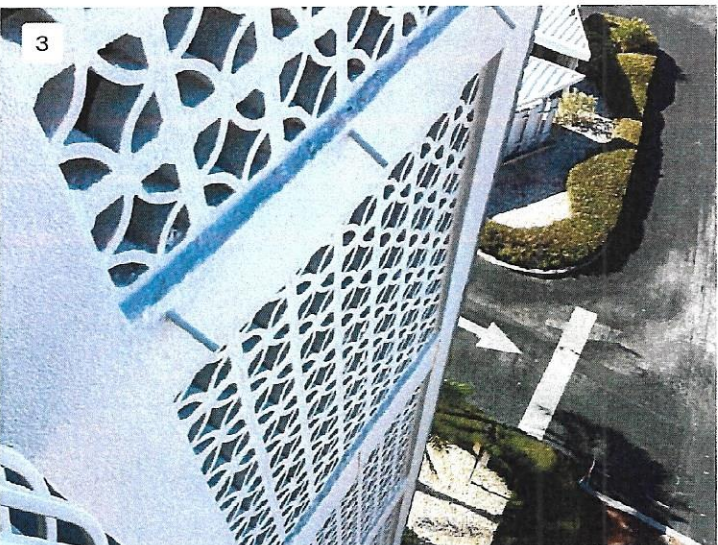
Landing drains in stairwell
