**Revised**  
**FULL RESERVE STUDY**  
**Town Shores of Gulfport,**  
**No. 203, Inc. (Dover House)**

**Gulfport, Florida**

**Inspected - January 26, 2021**

**Revised - March 10, 2021**

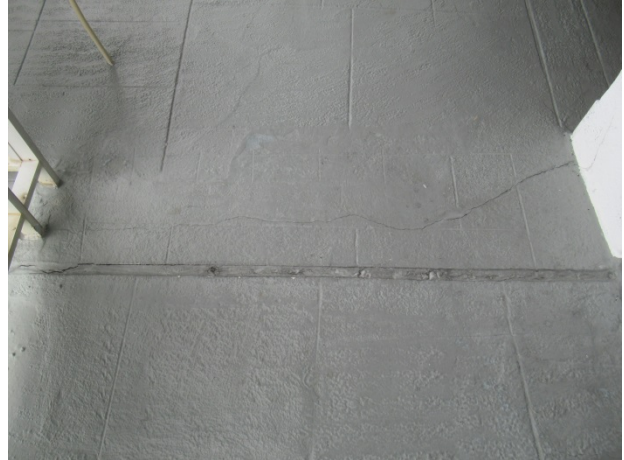
**Condition:** Good to fair overall with isolated cracks evident

**Concrete crack at expansion joint**

**Useful Life:** Capital repairs including a close-up visual inspection, patching of delaminated concrete, routing and filling of cracked concrete, and waterproof coating applications every 8- to 12-years.

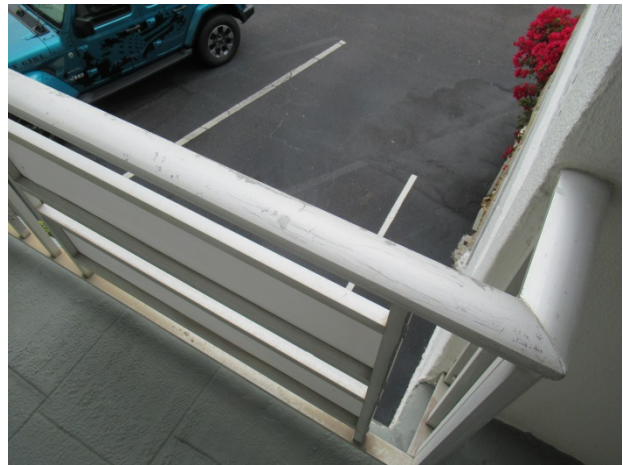
**Condition:** The railings are in good to fair overall condition and the railing finishes are in fair condition. The railings exhibit isolated stains and removed finish.

**Removed finish and stains**

**Useful Life:** Up to 40 years with the benefit of periodic maintenance. Periodic maintenance should include applications of a protective paint finish and partial replacement of deteriorated aluminum every 10- to 12-years based on information provided by the Board that paint applications will be completely covered under a 10 year warranty..

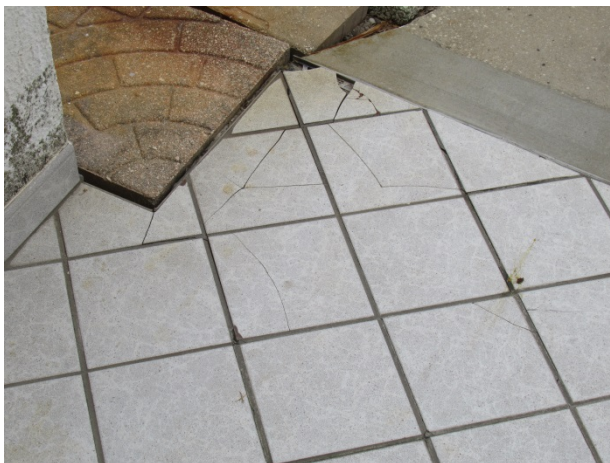
**Condition:** Good to fair overall

**Isolated cracked tiles at first floor**

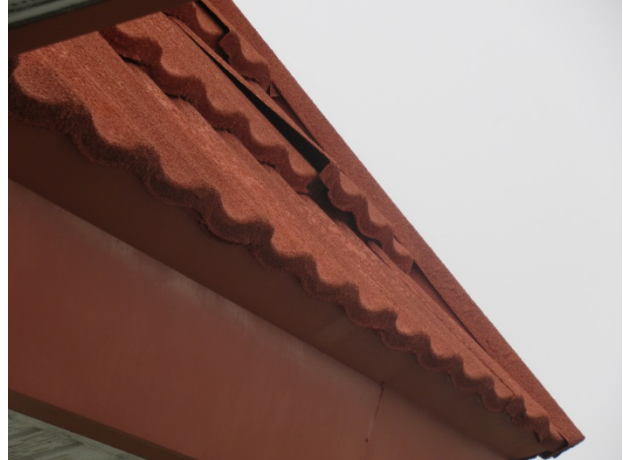
**Condition:** Good to fair overall with loose shingles evident. The Board does not report a history of leaks.

**Loose metal sheet**

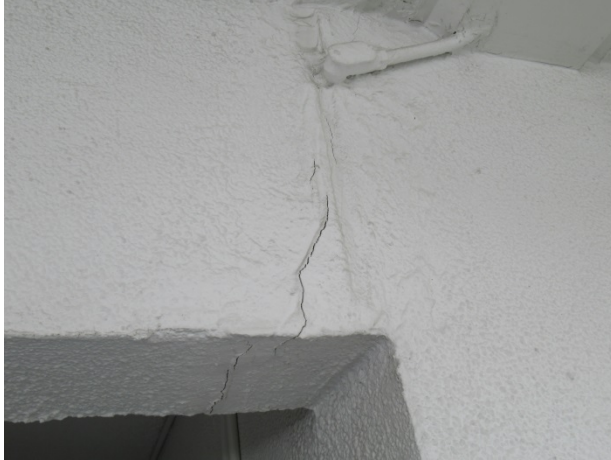
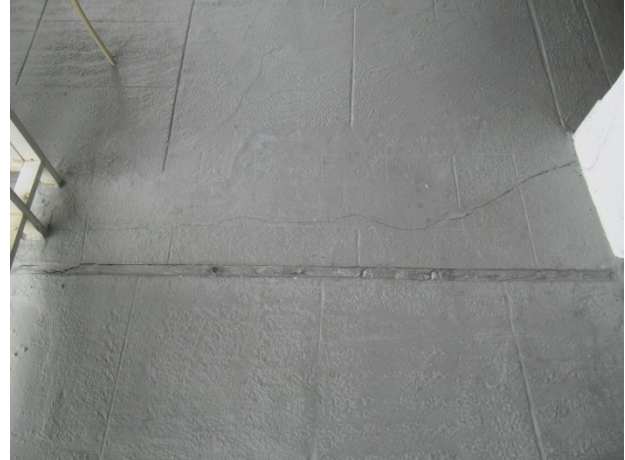
**Condition:** Fair overall

**Crack at expansion joint**

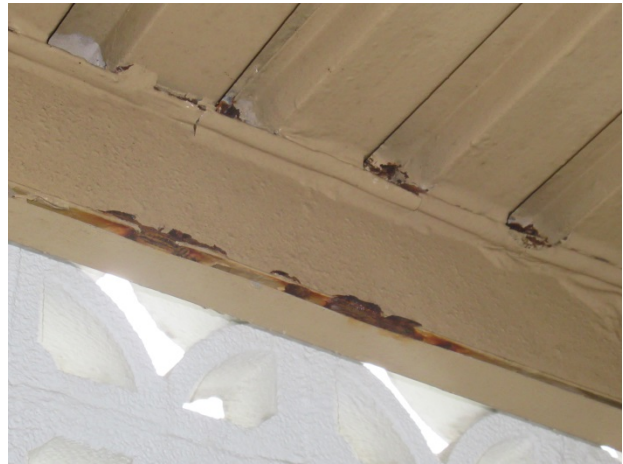
**Condition:** Good to fair overall with isolated rust

**Minor rust at staircase**

**Useful Life:** Up to 75 years for replacement with paint finishes and capital repairs every 10- to 15-years

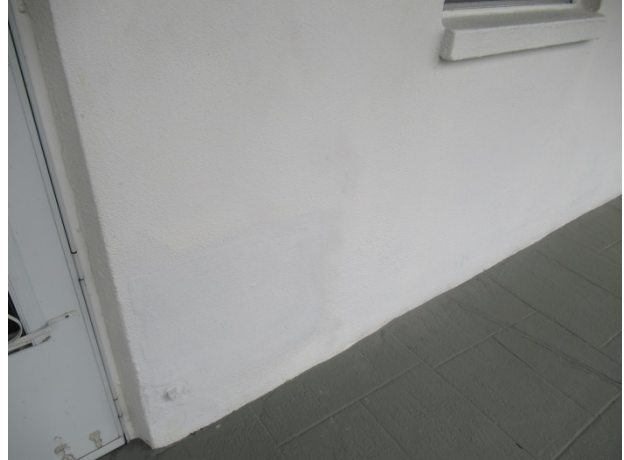
**Previous stucco wall repair**

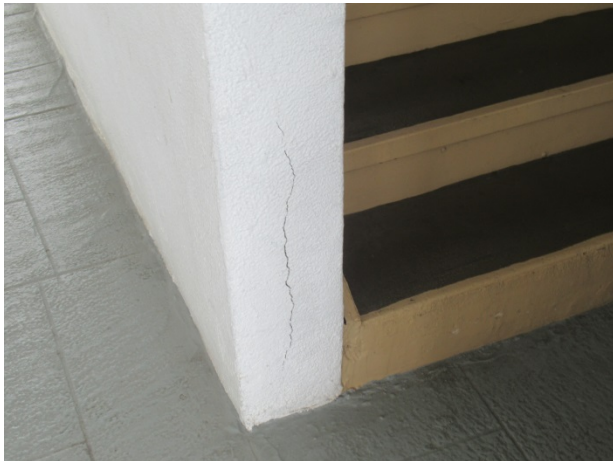
**Condition:** Good overall with isolated cracks evident

**Crack in stucco wall**

**Useful Life:** We recommend inspections, repairs and paint finish applications every 10- to 12-years based on information provided by the Board that paint applications will be completely covered under a 10 year warranty.

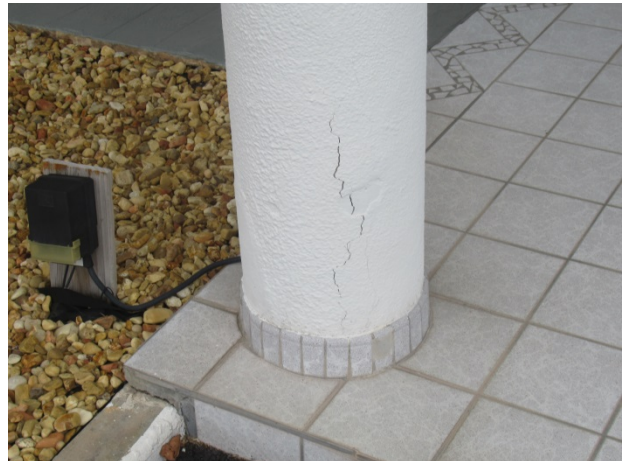
**Crack in column**

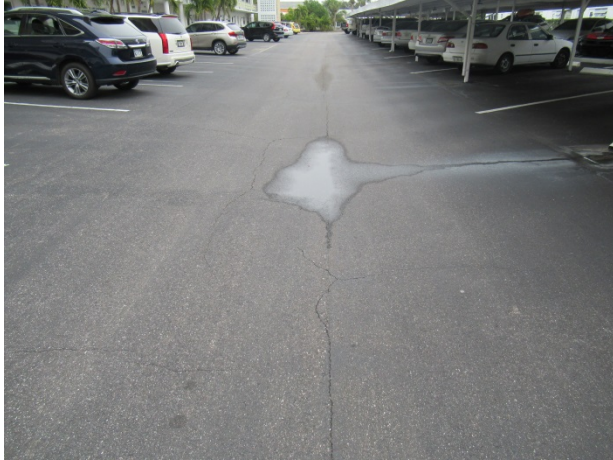
**Condition:** Fair overall with cracks and standing water evident

**Pavement cracks and standing water**

**Useful Life:** 15- to 20-years with the benefit of timely crack repairs and patching

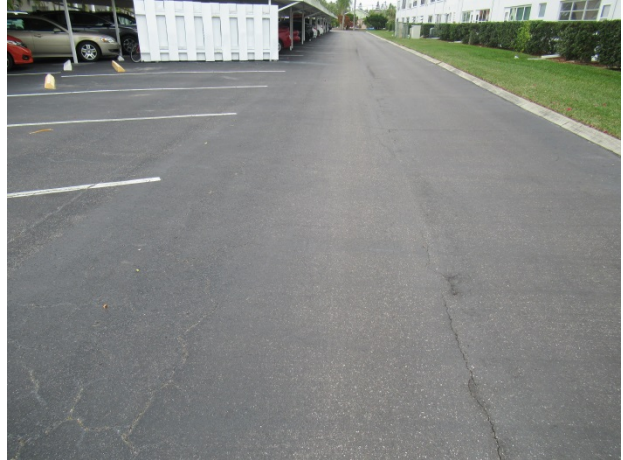
**Overview of pavement with cracks**

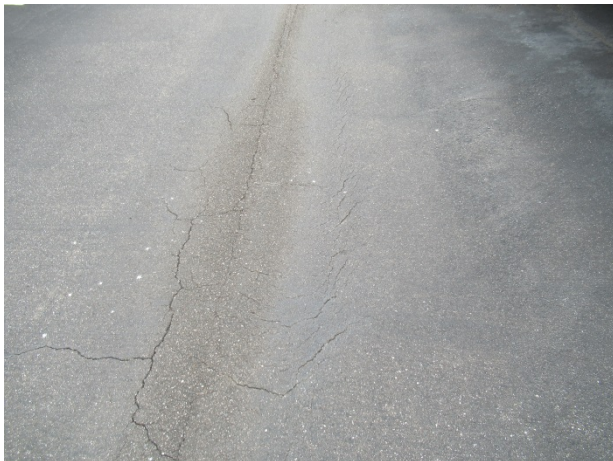
**Isolated slippage cracking**

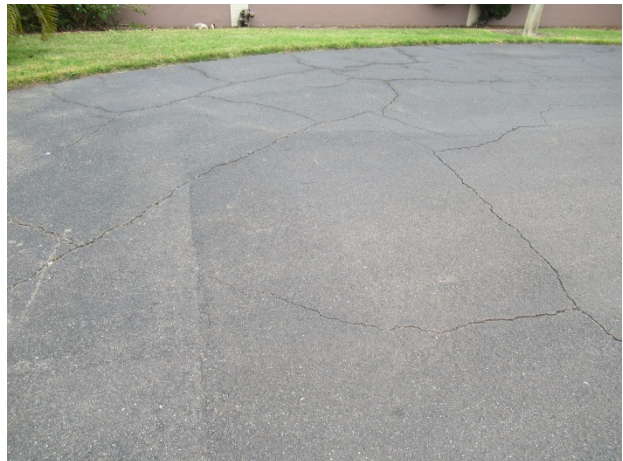
**Isolated block cracks**

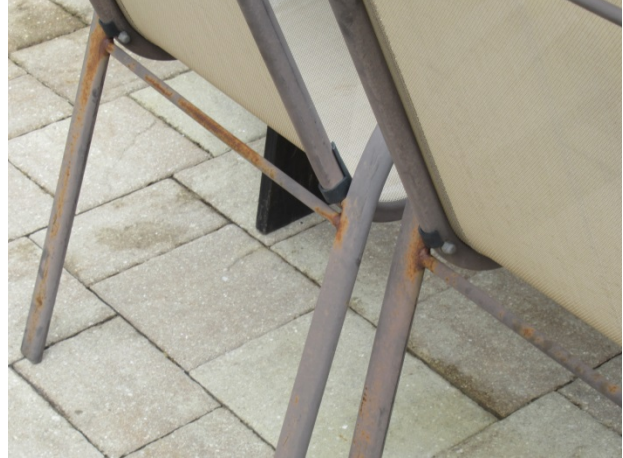
**Condition:** Fair overall

**Rust on chairs**
