1111 N. West Shore Boulevard, Suite 502
Tampa, FL 33607-4529
Tel: (813) 228-8212
JMannix@karins.com

December 6, 2022

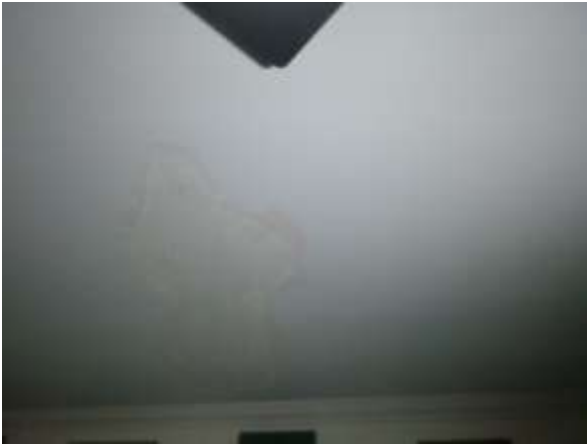
Photo 1: Stain and Crack at Ceiling of Unit 1007

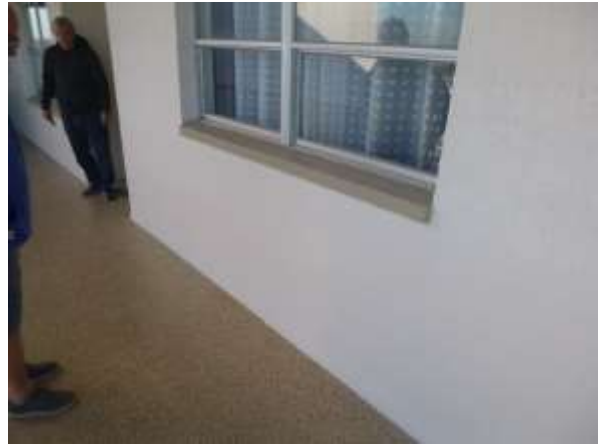
Photo 2: Walkway Area at PH6

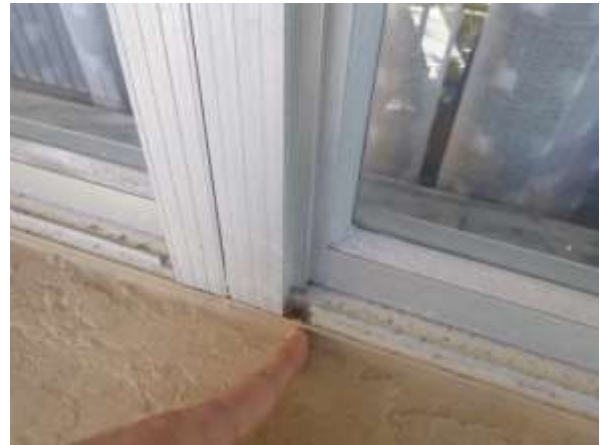
Photo 4: Rusted and Unsealed Window Fastener

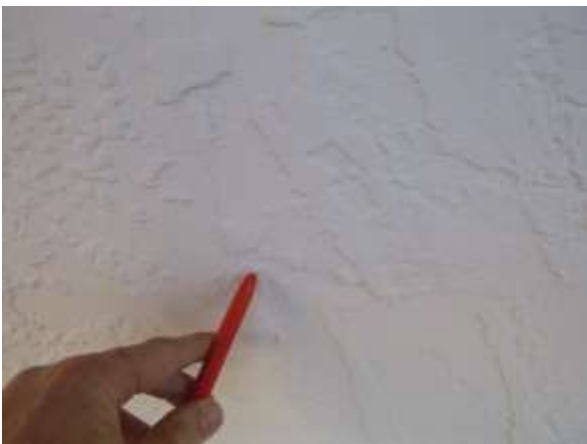
Photo 5: Hairline Stairstep Cracking at Stucco

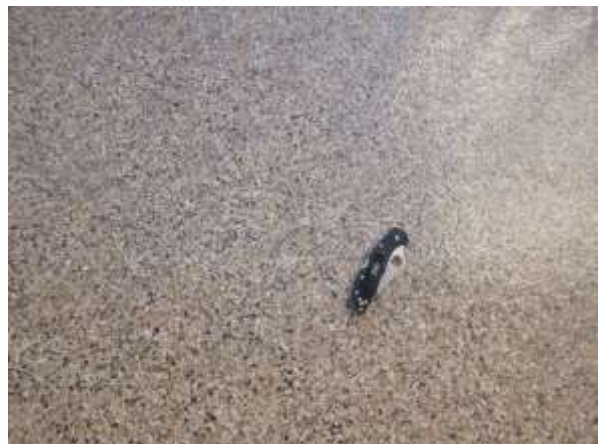
Photo 6: Spall at Walkway Surface

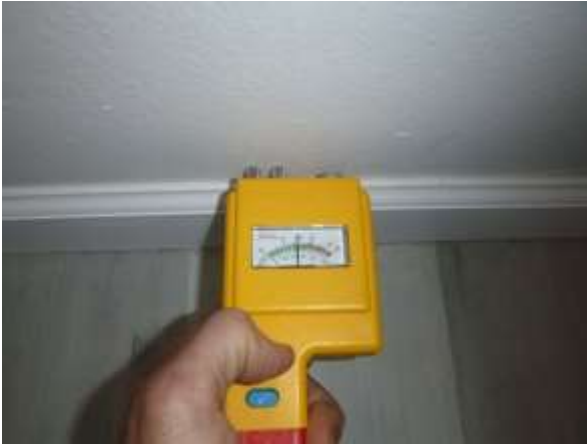
Photo 7: Moisture Reading below Window Mullion

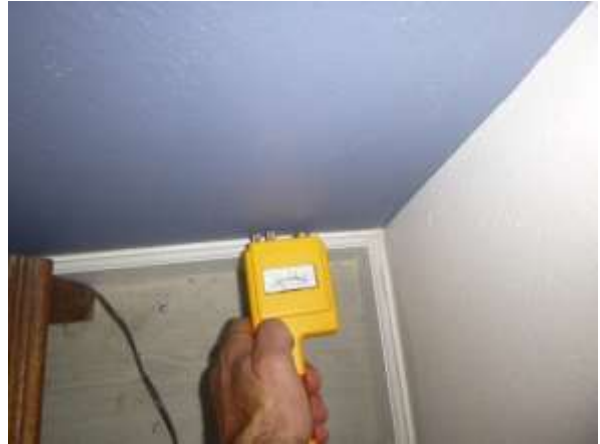
Photo 8: Relative Reading away from Window

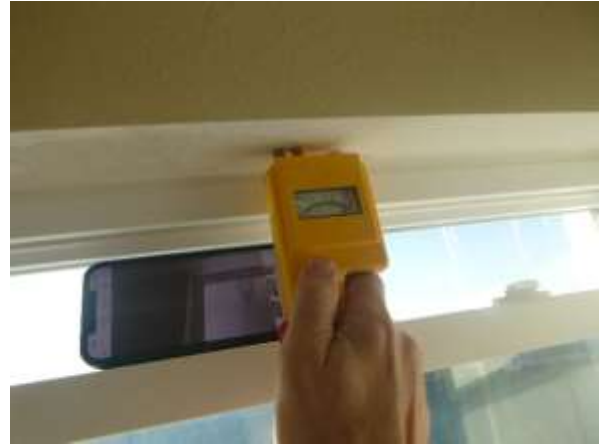
Photo 10: Moisture Reading above Window

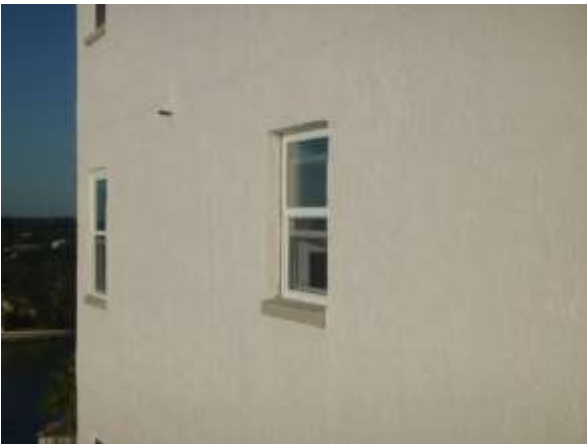
Photo 11: Exterior of Kitchen Window

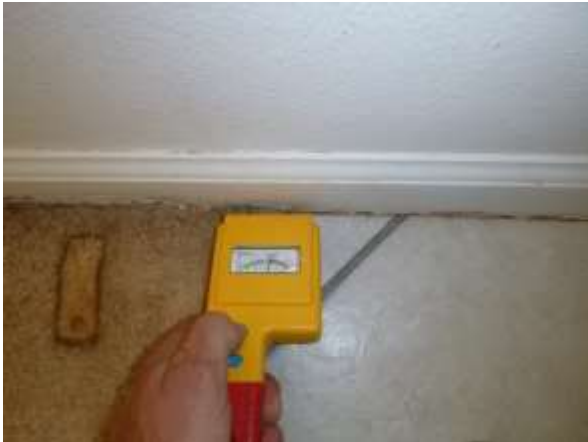
Photo 15: Moisture Reading at Unit 112 Baseboard

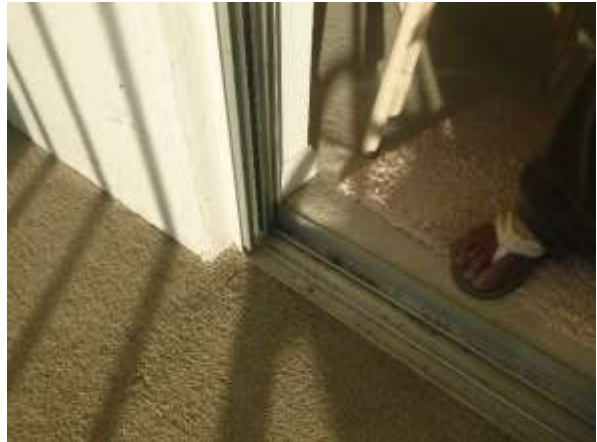
Photo 16: Track of Existing Sliding Glass Door
