**RE: Town Shores of Gulfport #217, Inc.
a/k/a Windsor Building Condominium
6020 Shore Drive South, Gulfport, FL 33707
KEG File# 22RT-1072**

Karins Engineering Group, Inc. (KE) agreed to render professional engineering services in connection with a Milestone Phase 1 Inspection at **Windsor Building at Town Shores Condominium** (hereinafter called the "Project"), located at **6020 Shore Drive South, Gulfport, FL 33707**, for **Windsor Building at Town Shores Condominium** (hereinafter called the "Client"), on September 13, 2022. Per the signed contract by the Client dated September 13, 2022, KE completed a limited condition observation and evaluation of the current condition and construction in November and December of 2022, as it relates to the building envelope and related structural components that readily accessible.

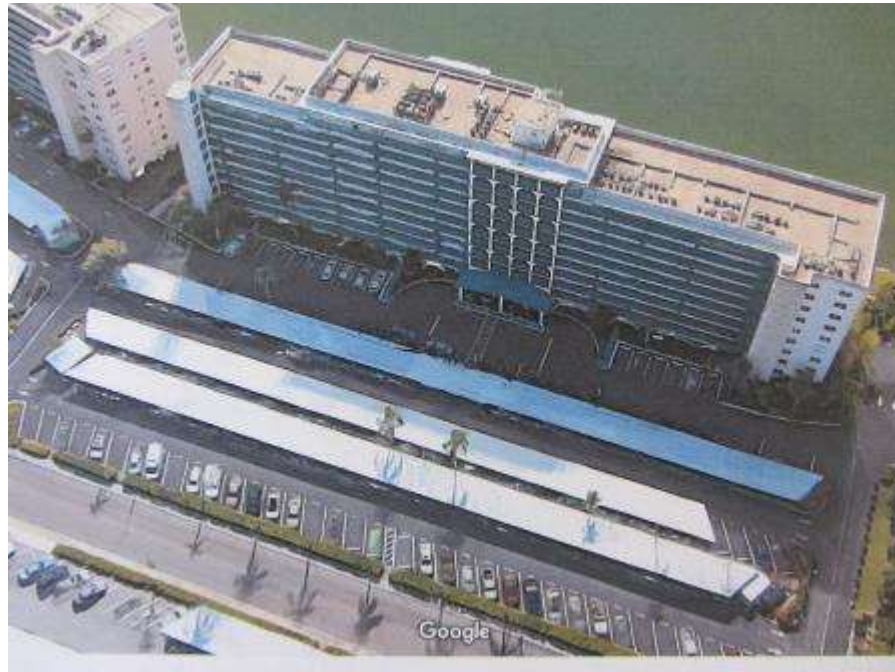
Photo #1 – Overview of front elevation

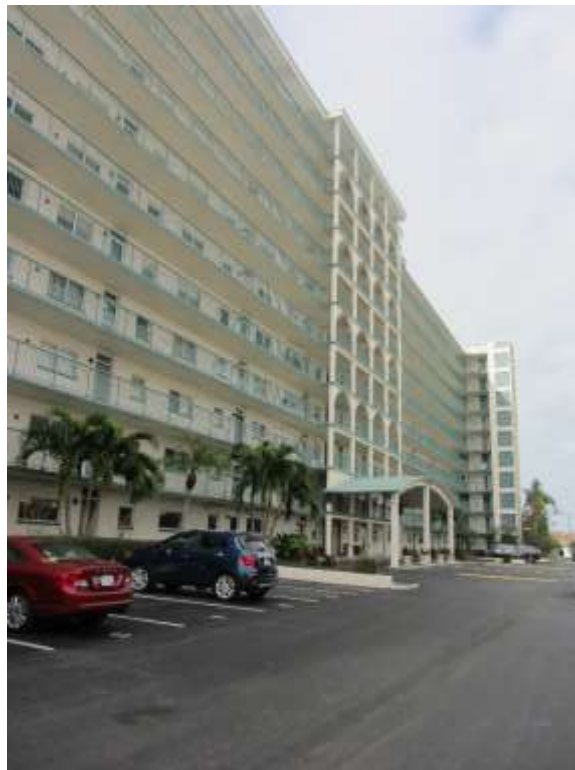
Photo #2 – Partial overview of front elevation of building

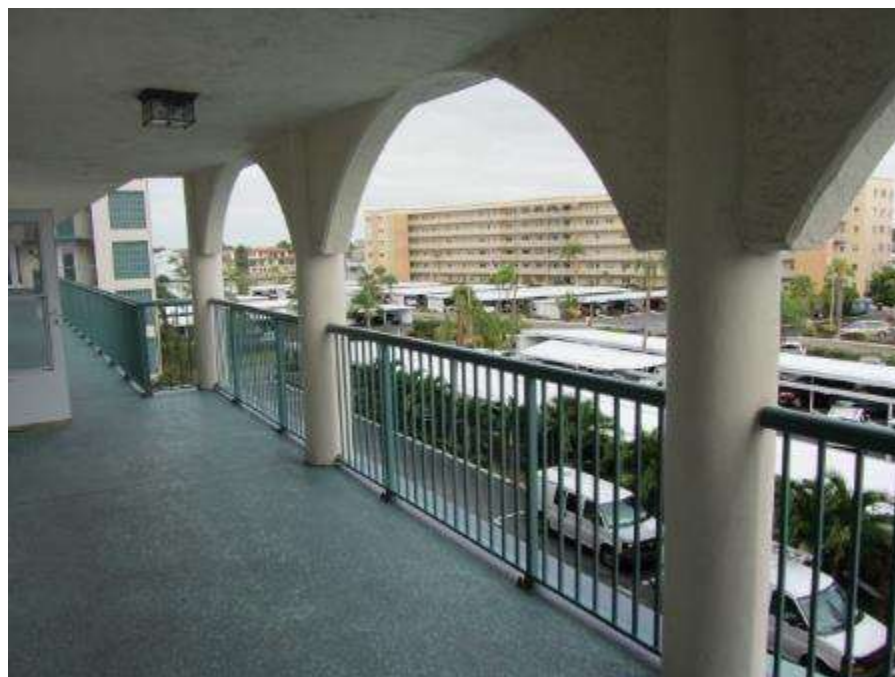
Photo #3 - Overview of common walkway, guardrail, arches, and columns on 4th floor.

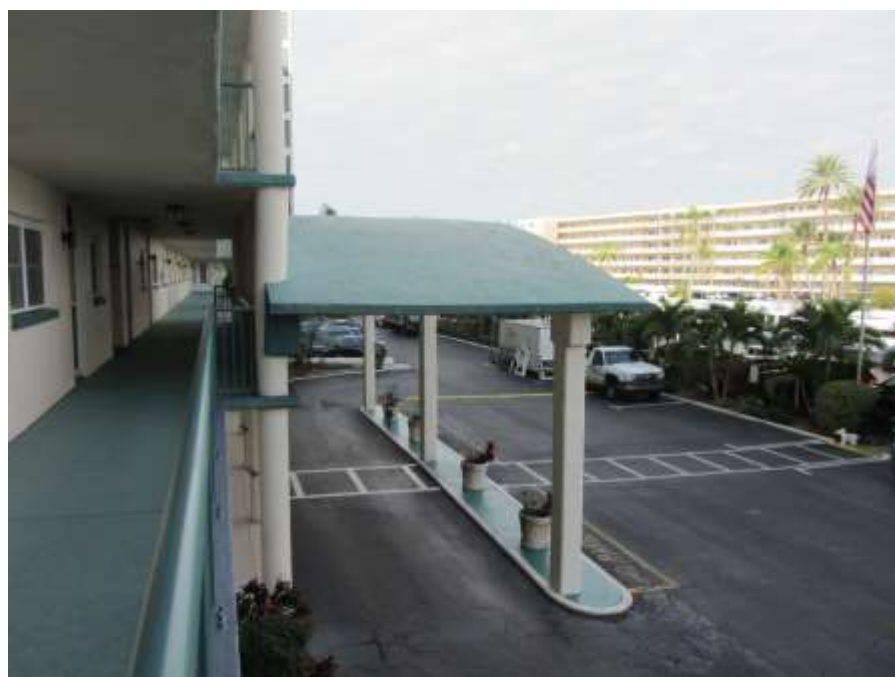
Photo #4 – Cover entry looking from east to west.

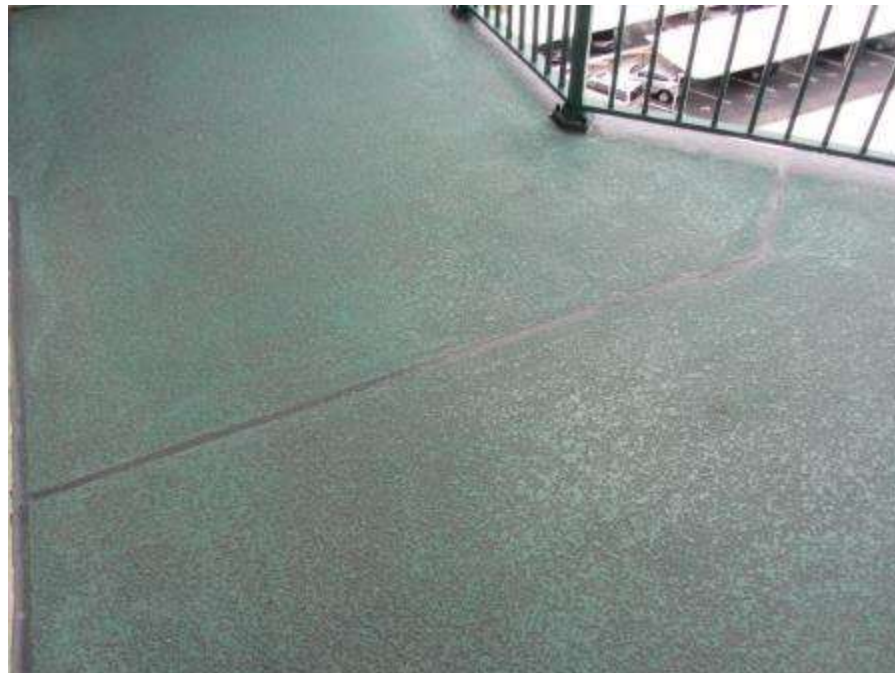
Photo #5 – Top side view of expansion joint at west end of walkway

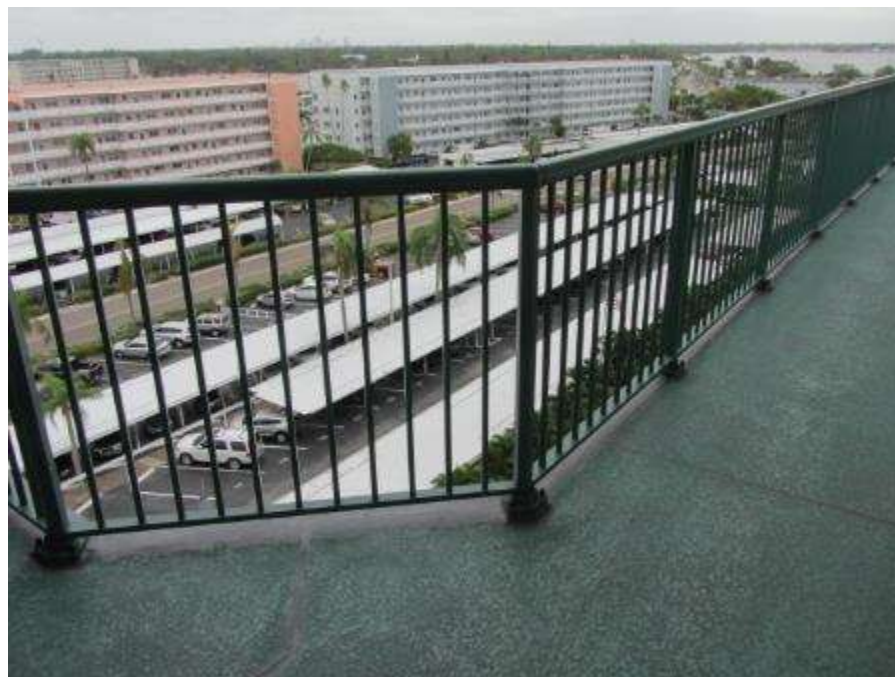
Photo #6 – Overview of guardrails and walkway looking from west to east.

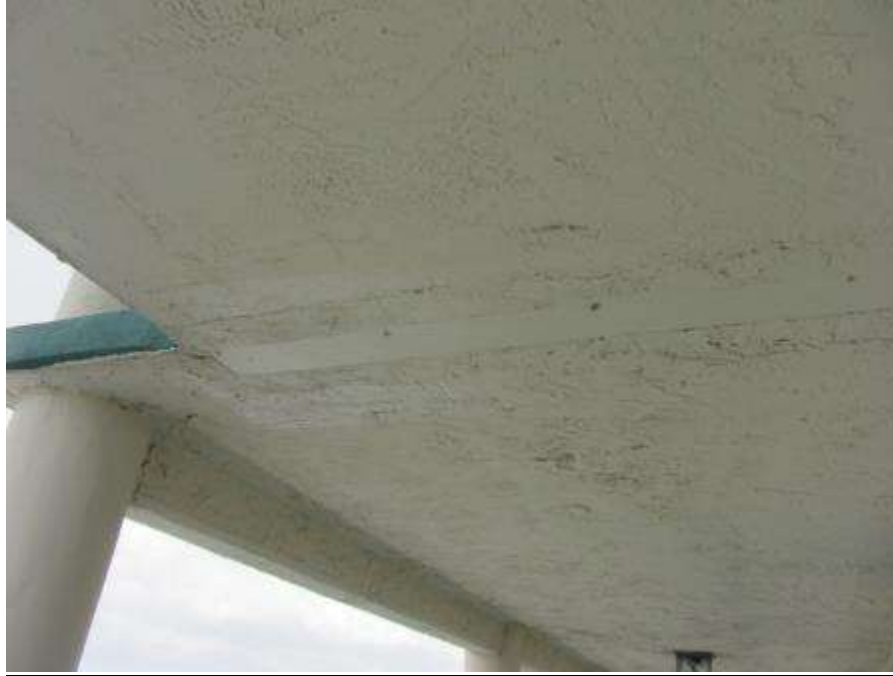
Photo #7 – Underside of typical expansion joint with cover plate attached along one edge

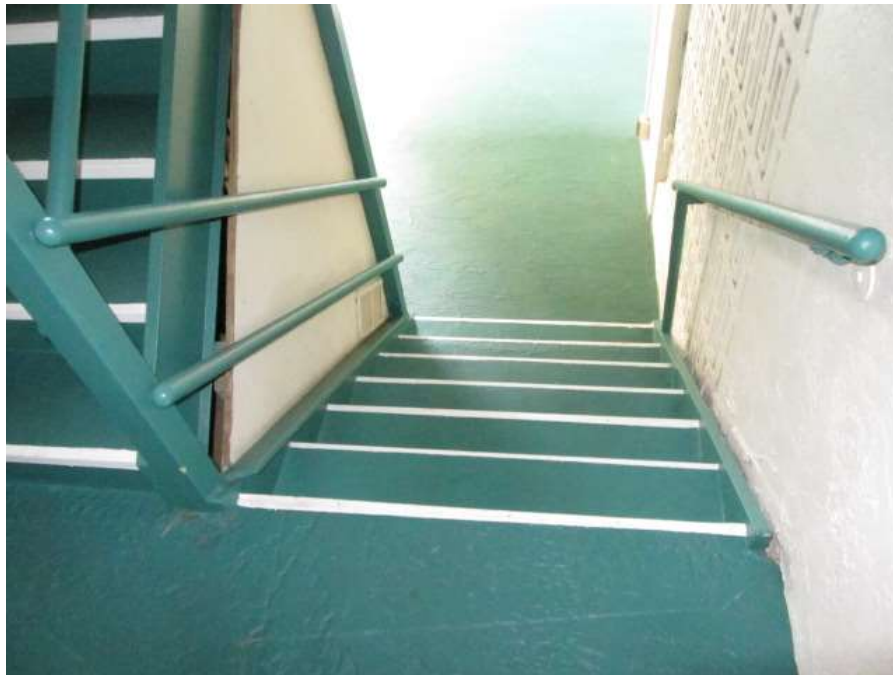
Photo #8 – Typical railings and flight of stairs in partially enclosed stair tower

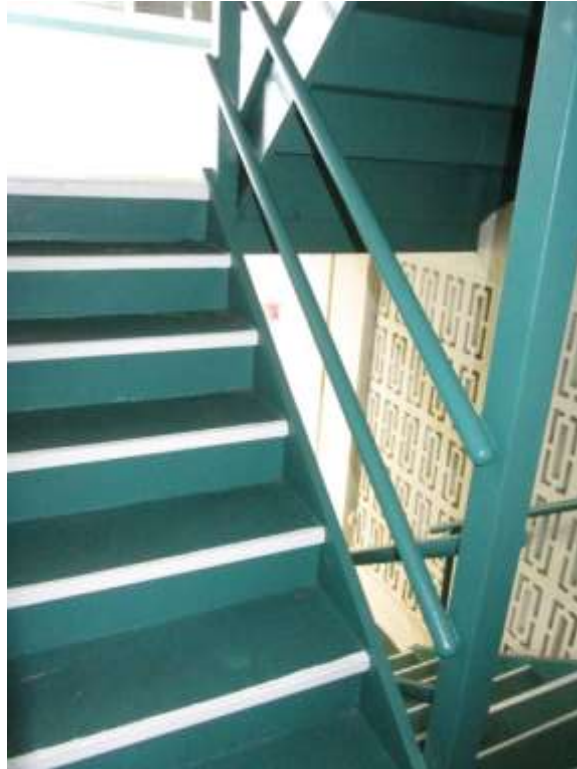
Photo #9 – Typical existing guardrail/handrail system in stair towers

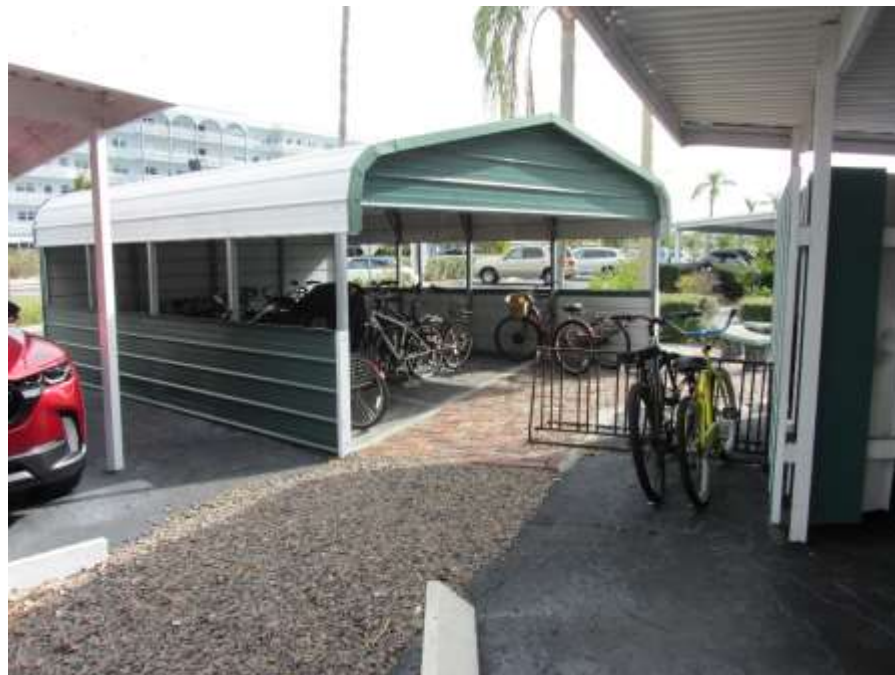
Photo #10 – Bicycle storage shed located in parking lot between carports.

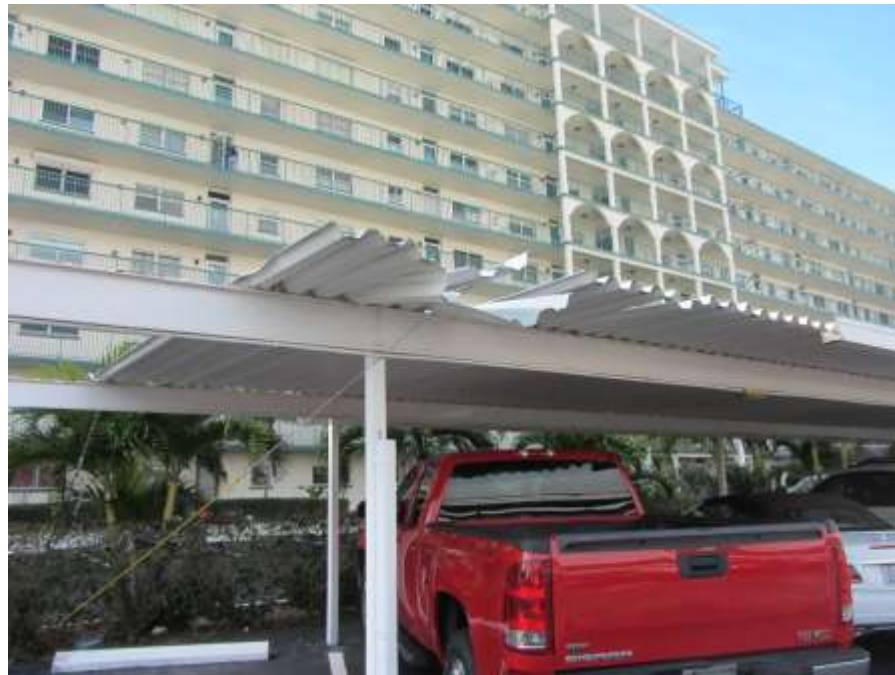
Photo #11 – Damaged carport structure

1. Repair carport awning blown off by Hurricane Ian.
2. Further investigation into the buildings specific structural components should be considered. Our inspection was observational only.
3. Institute a monthly maintenance schedule for the stairways, and common walkways to check railings, fasteners, and expansion joints.
4. Consider locking the individual AC compressor disconnect boxes and the Meter Doors at each building.
5. Consider replacement of any rusted service doors on the exterior.

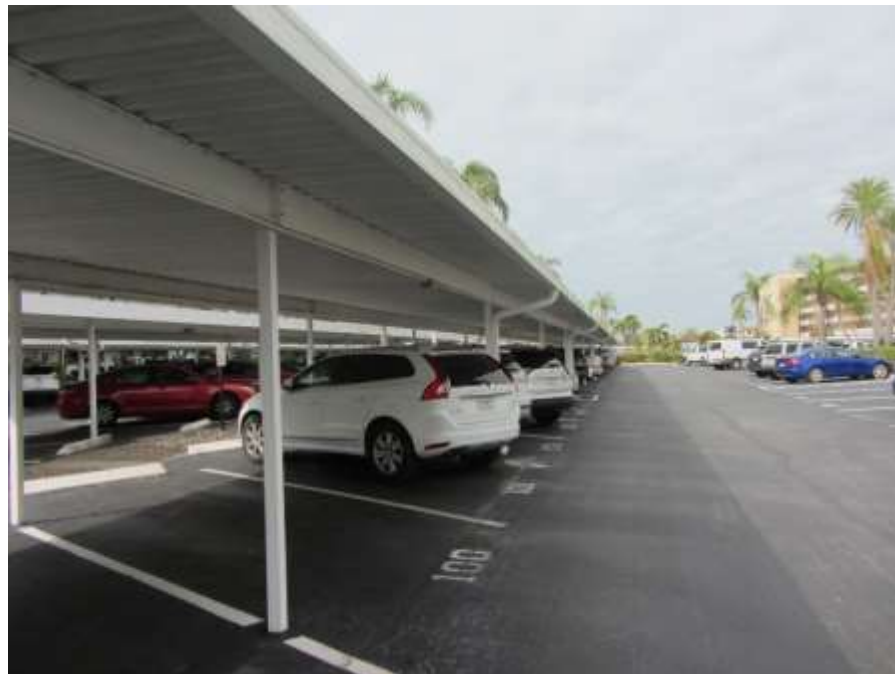
Photo #12 – Typical carport

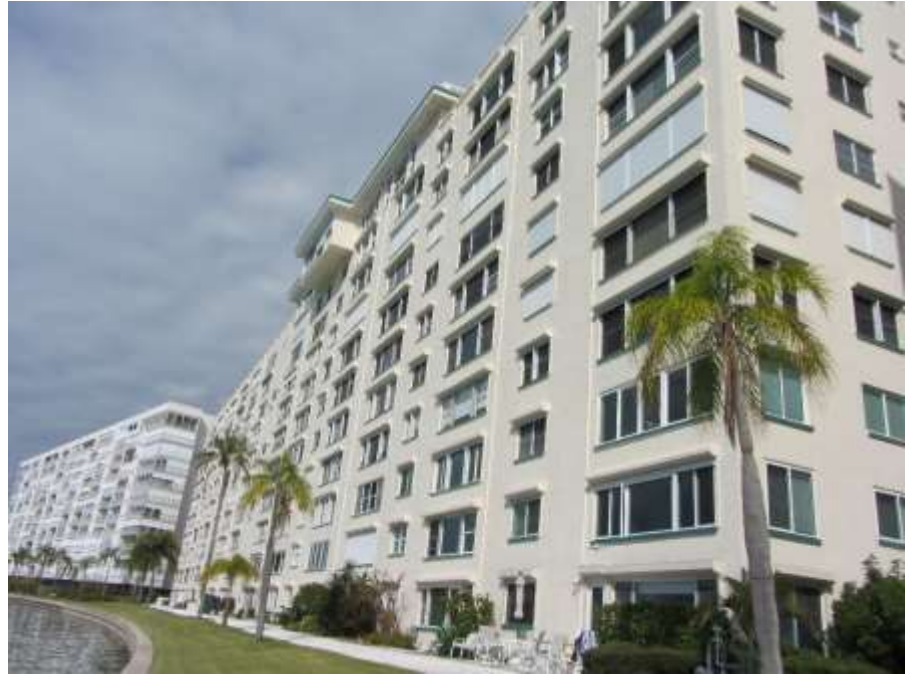
Photo #13 – Overview of rear (south) elevation of building

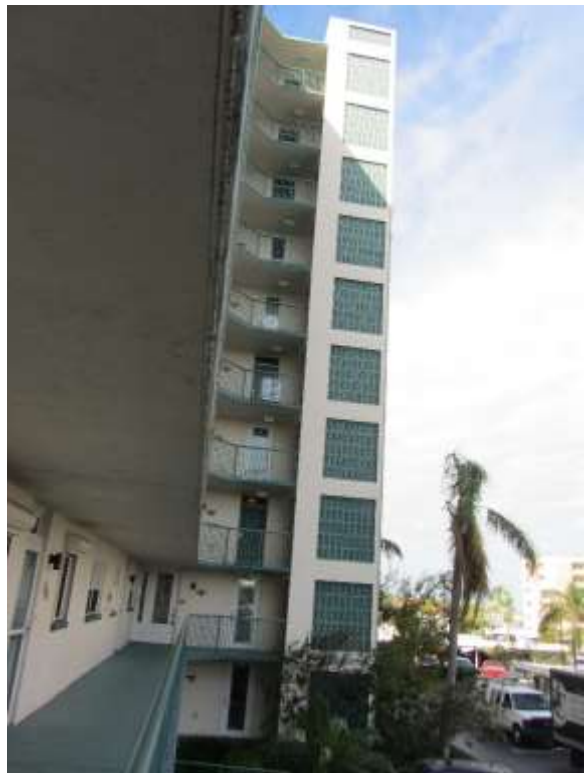
Photo #14 – West end stair tower
