Reserve Study

Prepared for the Board of Directors for the
Town Shores Of Gulfport # 216 COA

6075 Shore Blvd S, Gulfport, FL 33707

July 1, 2024

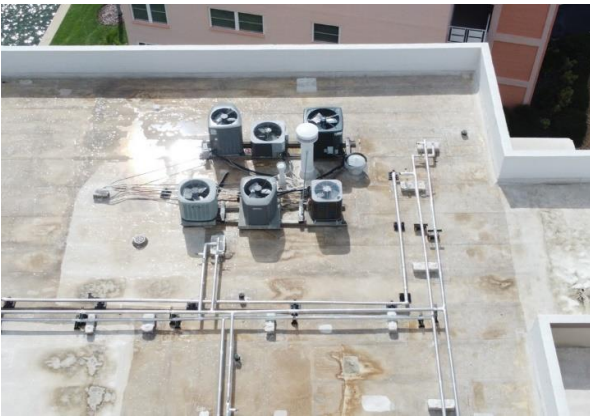
9 HVAC Stands (FBC Upgrade needed)

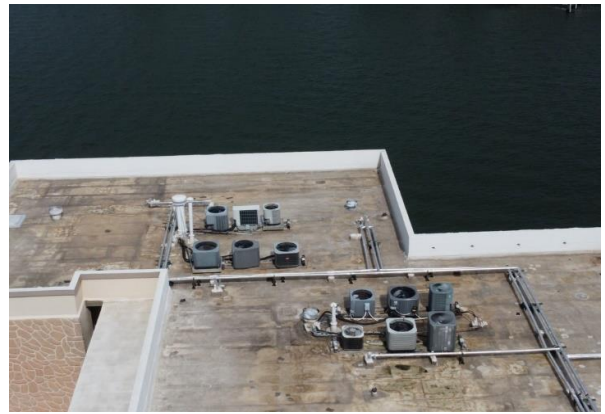
10 HVAC Stands (FBC Upgrade needed)
