MILESTONE PHASE 1 EXISTING BUILDING INSPECTION REPORT STRUCTURAL SUMMARY

6500 47th Street North, Unit 7, Pinellas Park, FL 33781

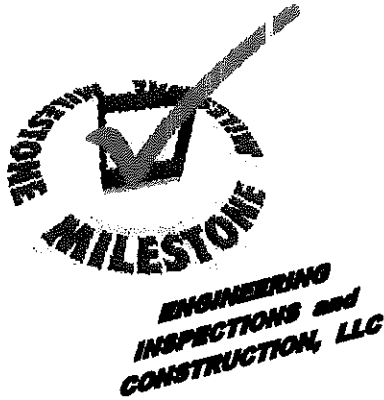
6500 47th Street North, Unit 7, Pinellas Park, FL 33781

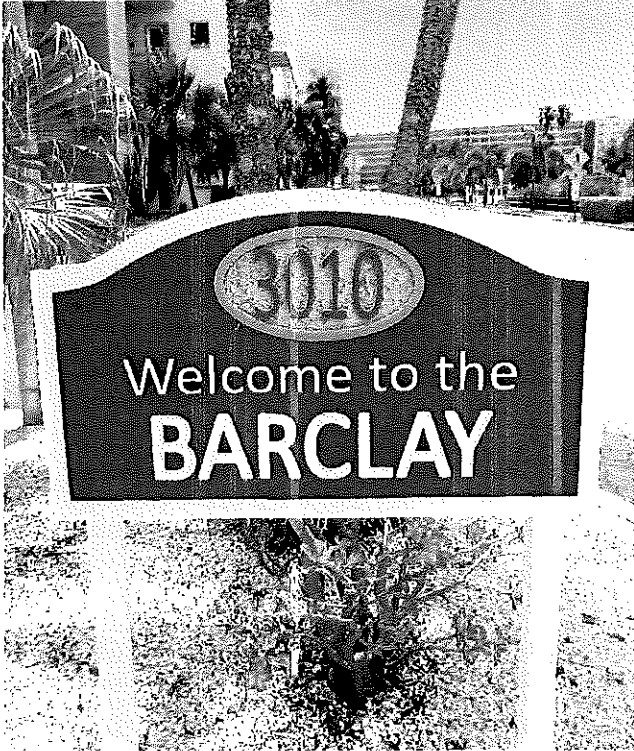
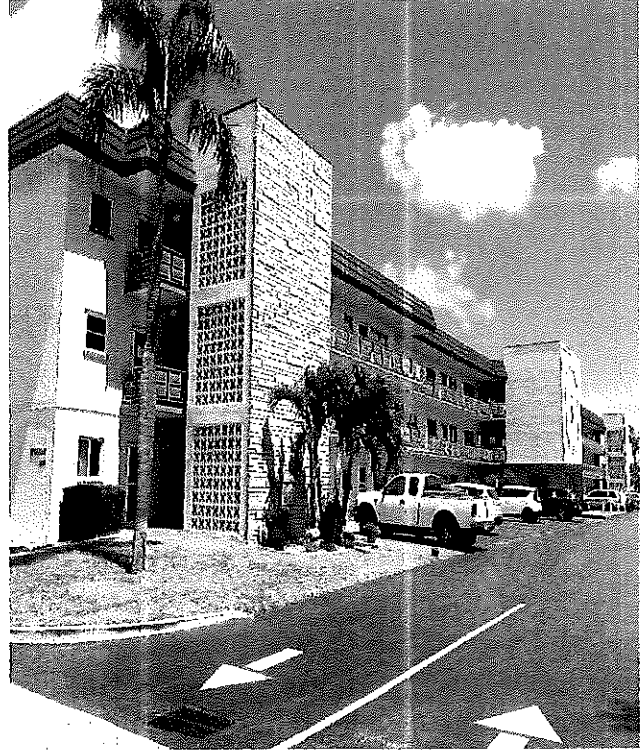
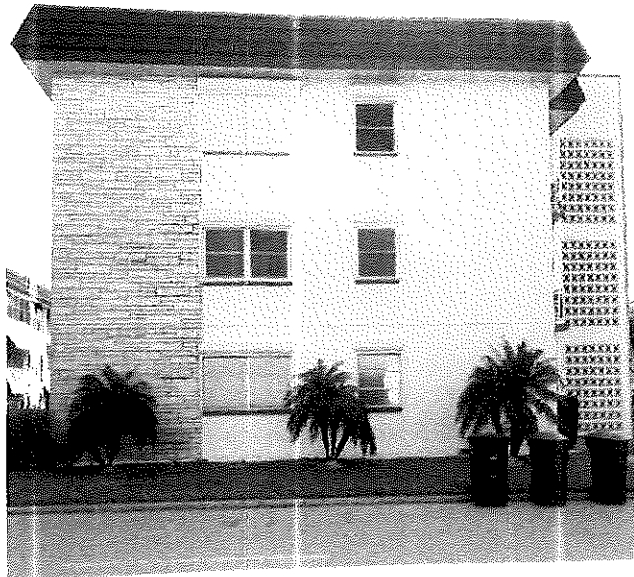
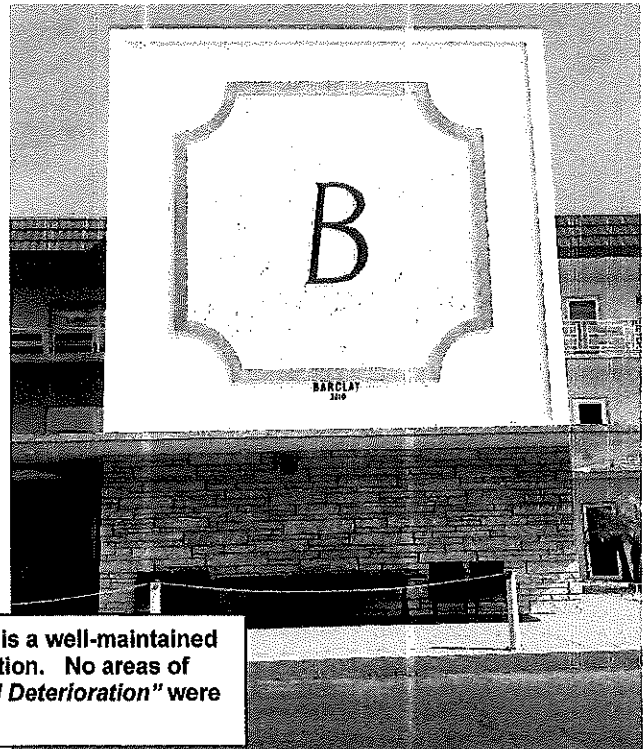
Overall Barclay House is a well-maintained building in good condition. No areas of "Substantial Structural Deterioration" were observed.

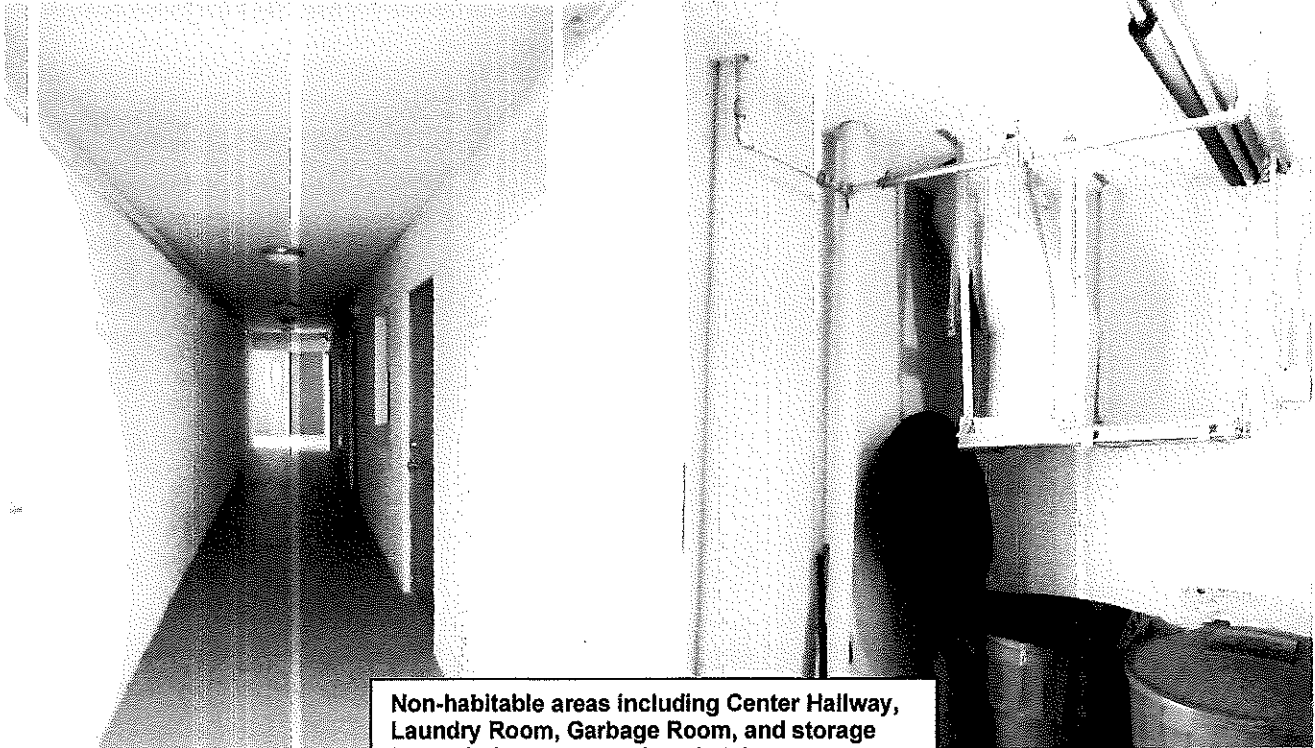
Non-habitable areas including Center Hallway, Laundry Room, Garbage Room, and storage beneath the center enclosed stairs were examined and found to be in good condition.

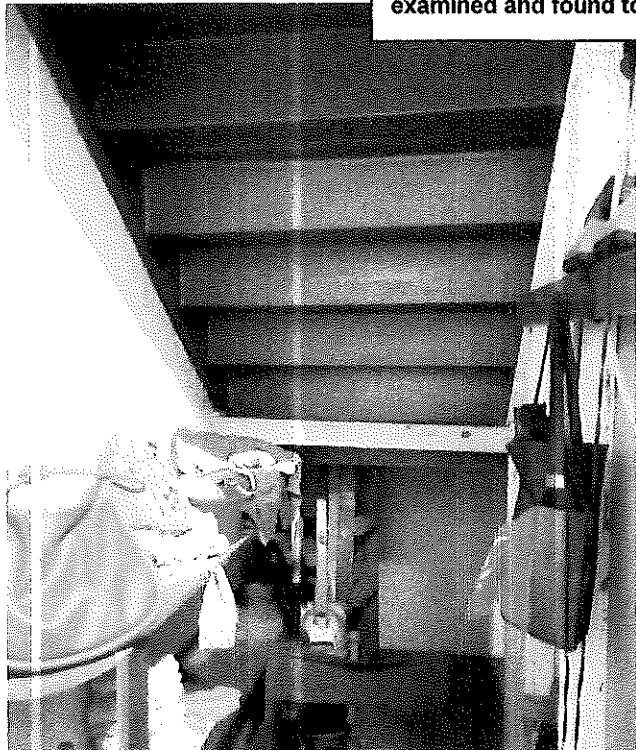
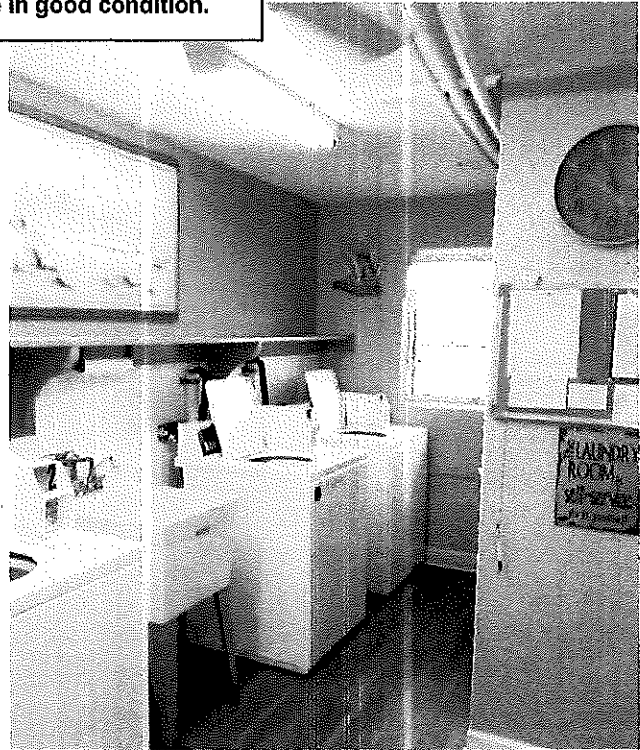
**Town Shores of Gulfport # 201, Inc. – Barclay House
Milestone Phase One**

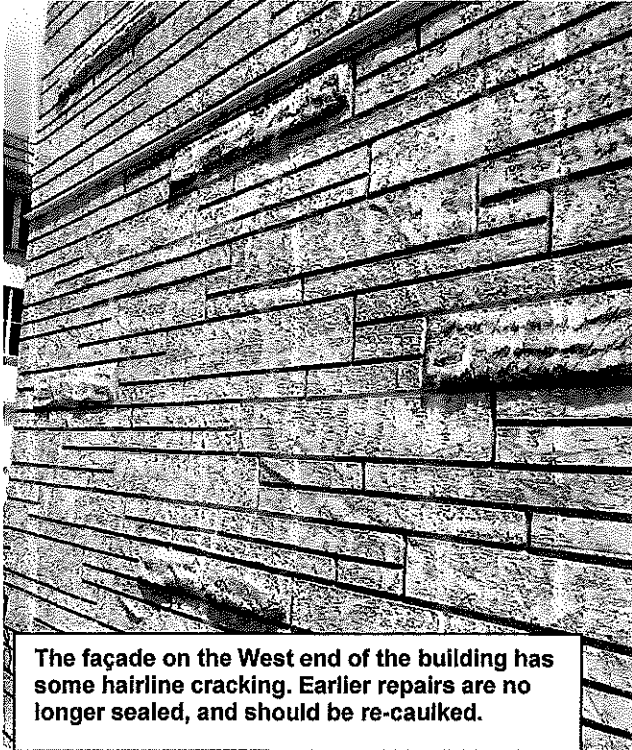
The façade on the West end of the building has some hairline cracking. Earlier repairs are no longer sealed, and should be re-caulked.

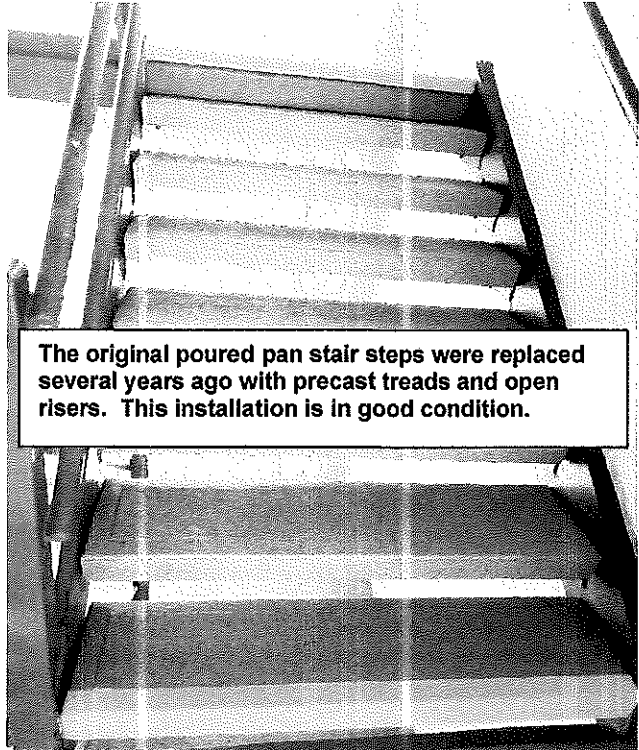
The original poured pan stair steps were replaced several years ago with precast treads and open risers. This installation is in good condition.

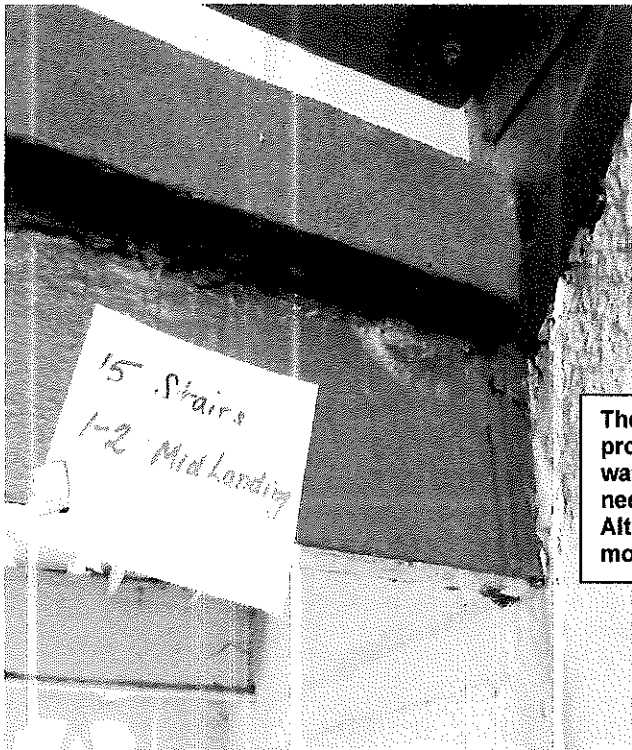
The staircase structure has open blocks on two sides to promote ventilation. During periods of wind driven rainfall, water enters the structure, and periodic painting maintenance is needed to stem the advance of rust on the steel components. Although steel components can be repaired indefinitely, it is far more cost efficient to prevent the rust.

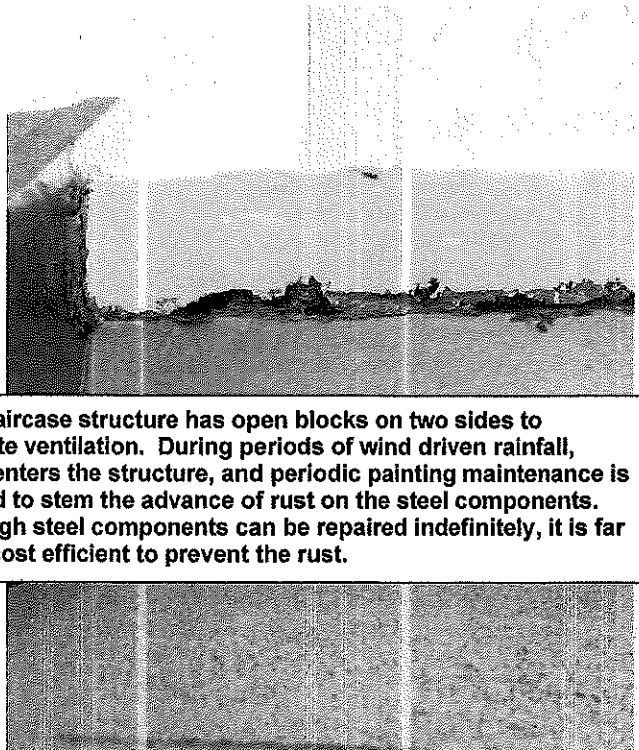
**Town Shores of Gulfport # 201, Inc. – Barclay House
Milestone Phase One**

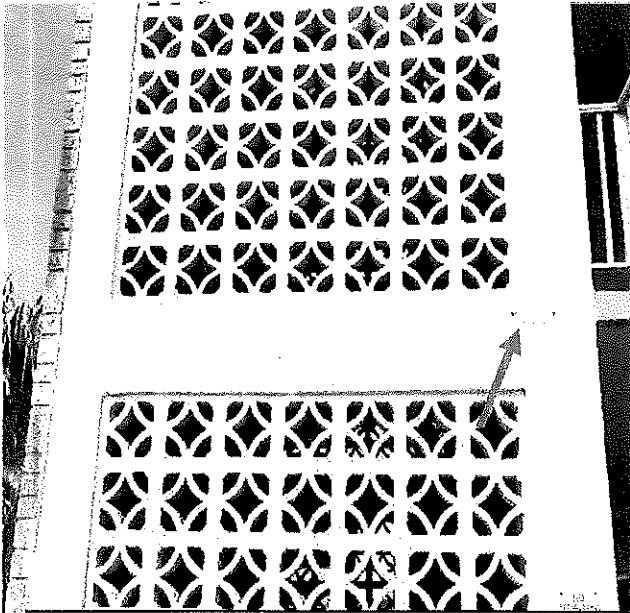
At the "01" Stack staircase, there were two rebar ends, which had popped out a little concrete because they were installed too close to the outer surface. This is a minor maintenance repair.

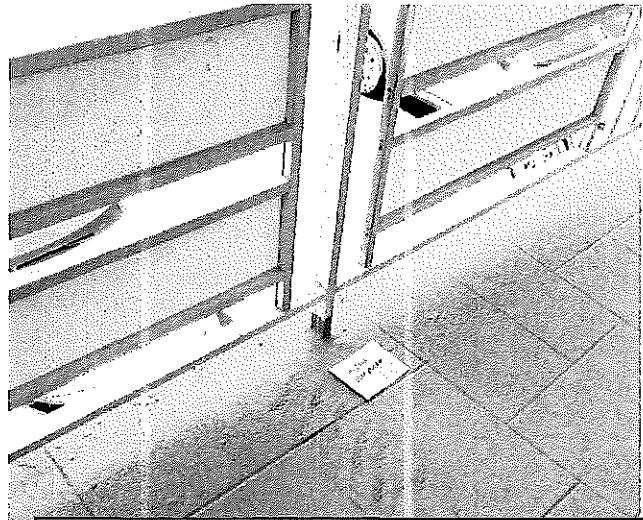
The posts for the railings occasionally will become loose. There are several, which may need maintenance to be sure they are firmly sealed. Adjacent edges of the slabs need to be checked for minor spalling.

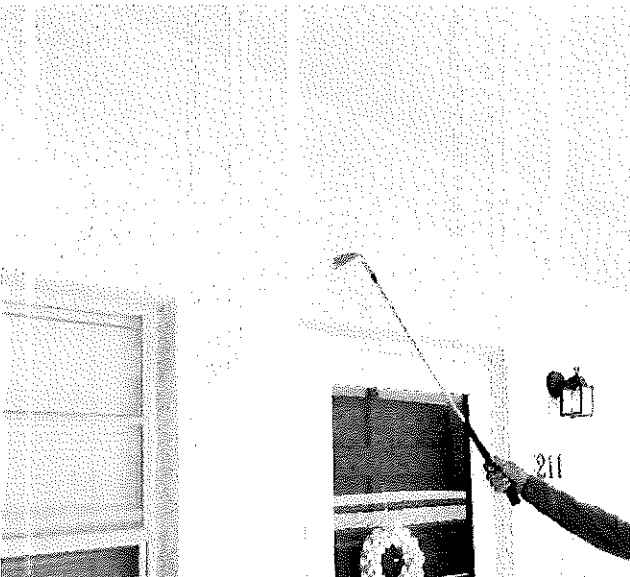
Using a metallic sounding technique, there were several places where the stucco on the rear wall of the walkway was disbonded from the wall behind, but there was no indication of cracking. This is a fairly common condition, which usually is completely benign. This side of the building faces South and as such is subjected to a great deal of sun exposure. Normal expansion and contraction of the building can often result in portions of stucco becoming disbonded from the wall behind it. If cracking should develop or a section push out this will often signal corrosion or rebar or another condition. At this time however, monitoring surfaces for cracking is the recommended course of action.
