PRESCOTT ENGINEERING, LLC

May 17, 2022

**Subject: Building Condition Survey
Buckingham Condominiums
6060 Shore Blvd. S.
Gulfport, Florida**

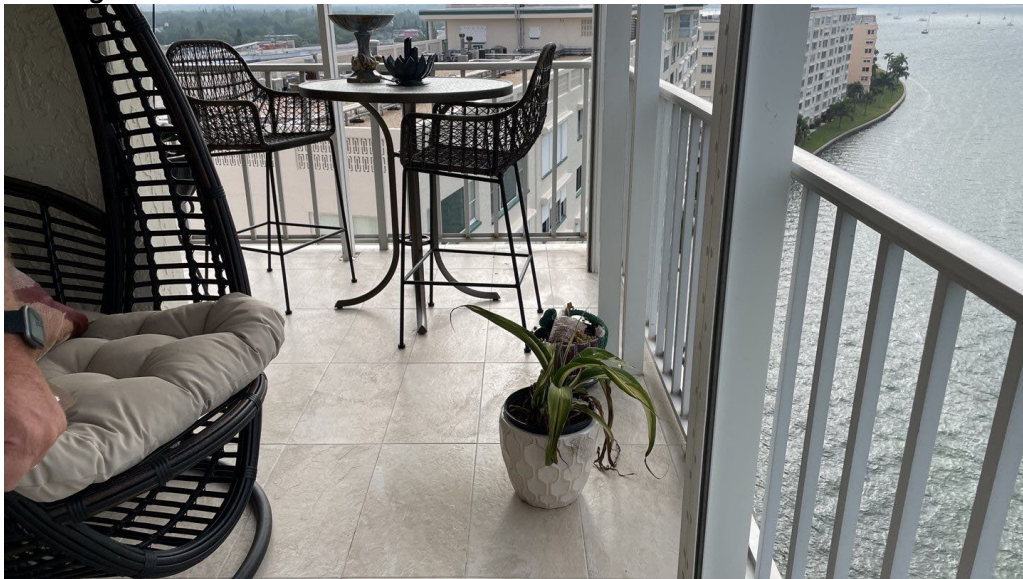
Figure 1

1. A total of 42 balconies were surveyed and included Units 101, 102, 103, 105, 109, 111, 200, 201, 206, 302, 304, 308, 312, 406, 409, 410, 502, 503, 505, 507, 512, 600, 604, 610, 700, 701, 703, 711, 800, 805, 806, 902, 907, 908, 911, 912, 1004, 1007, 1010, P1, P7, and P10.
2. Of the balconies that were surveyed, 33 were found to be covered with floor tile. Refer to *Figure 1*.

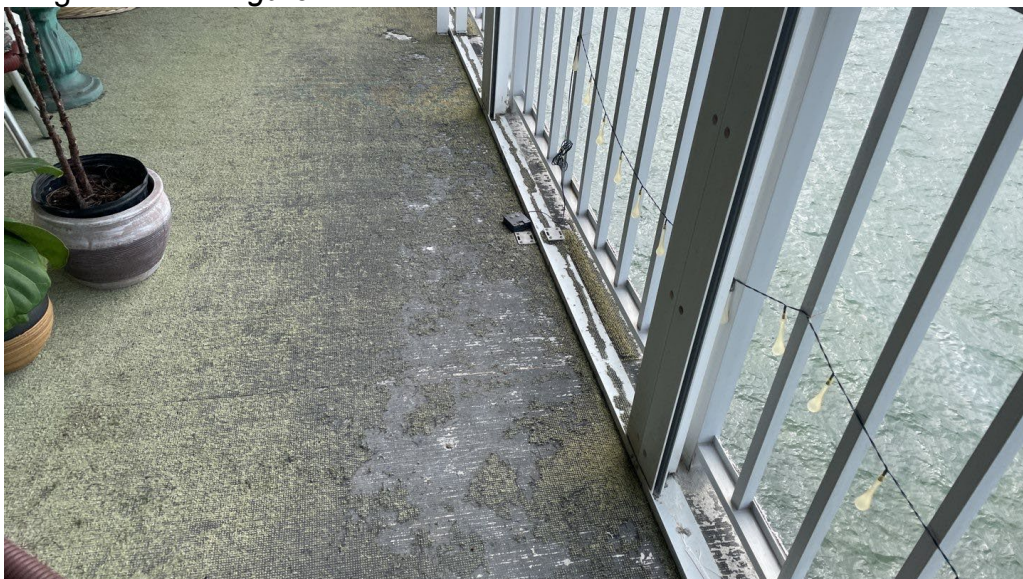
Figure 2

3. The balconies of Units 111, 304, 409, 507, 600, 610, and 908 were covered with carpeting. Refer to *Figure 2*.

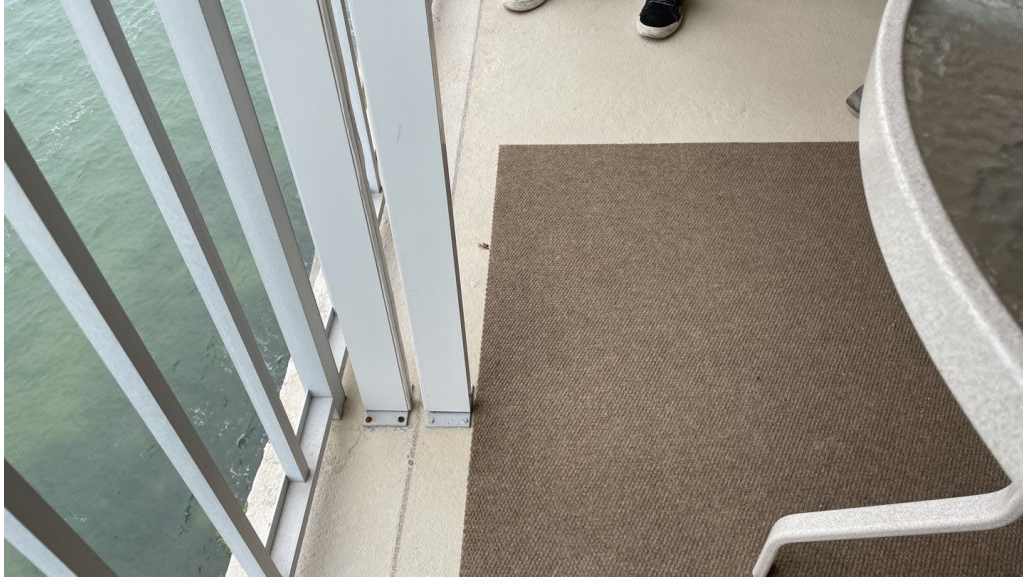
Figure 3

4. The balconies of Unit 406 and 805 were coated with paint. Refer to *Figure 3*.

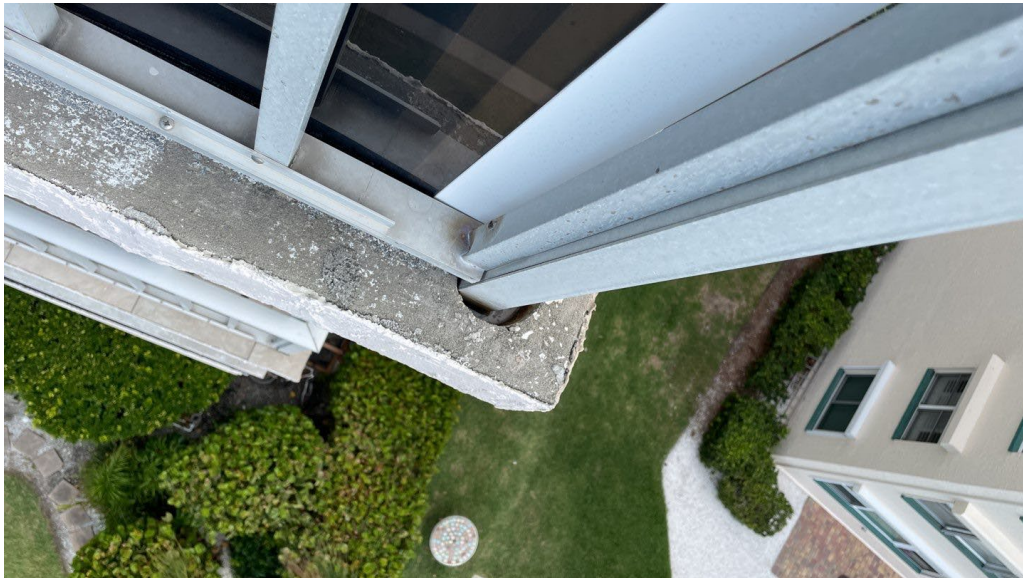
Figure 4

5. The post pockets for the guardrail system on balconies 312 and 600 were found to be improperly filled. This condition will allow water to accumulate in the pocket and drain into the balcony slab. Refer to *Figure 4*.

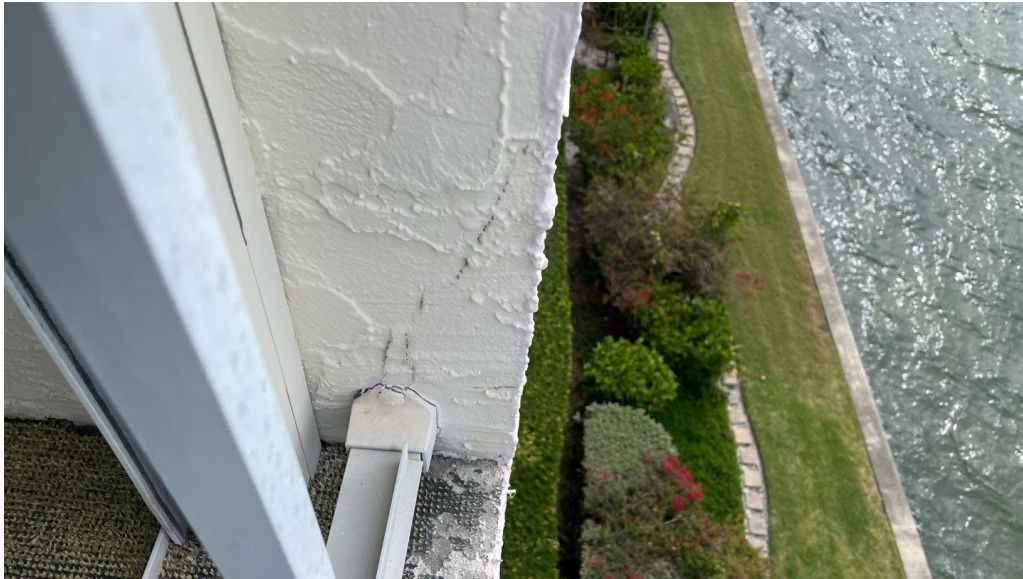
Figure 5

6. Vertical spalling was observed in the walls and columns of the balconies of Units 111, 105, 206, 312, 409, 410, 610, 805, 912, and P10. Refer to *Figure 5*.

Spalling occurs when moisture and chlorides from the ocean are able to penetrate the deck and reach the reinforcing bars. When exposed to moisture and chlorides the reinforcing bars will corrode. The corrosion causes the reinforcing bars to expand which in turn creates internal stresses in the concrete. These internal stresses cause areas of the concrete to break loose and expose the reinforcing bars. The breaking loose of the concrete is what is referred to as "spalling". Spalling generally affects older buildings near the water more than it affects newer construction that is inland. Periodic maintenance and application of a quality waterproofing membrane on the walkway, balconies, and parking deck can significantly reduce the amount of repairs that are needed in the future.

1. The spalling in the columns, balconies, and walkways should be repaired in accordance with guidelines prepared by the International Concrete Repair Institute (ICRI). This includes the following:

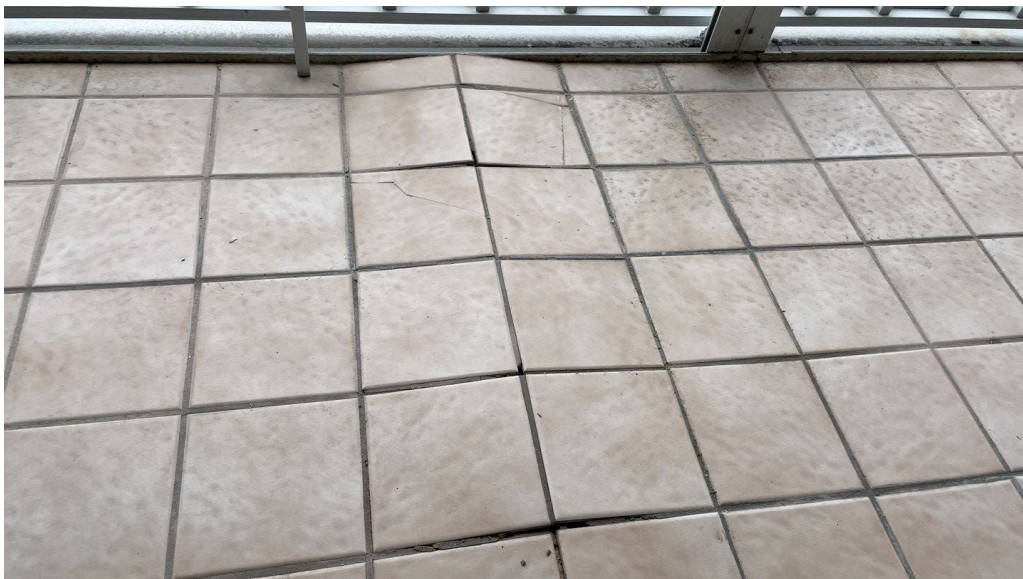
Figure 7

7. More than 20% of the floor tiles on the balconies were observed and/or detected by sounding to be delaminated on the balconies of Units 109, 201, 302, 410, 604, 703, 902, 907, 911, 912, 1004, and P10. Refer to *Figure 7*.

- h. Application of an appropriate concrete repair material
 - i. Application of a waterproofing membrane in these areas
 - j. It is recommended that the tiles on the balconies be removed so that the balconies can be properly waterproofed. Various floor finish options can be applied overtop the urethane coating.

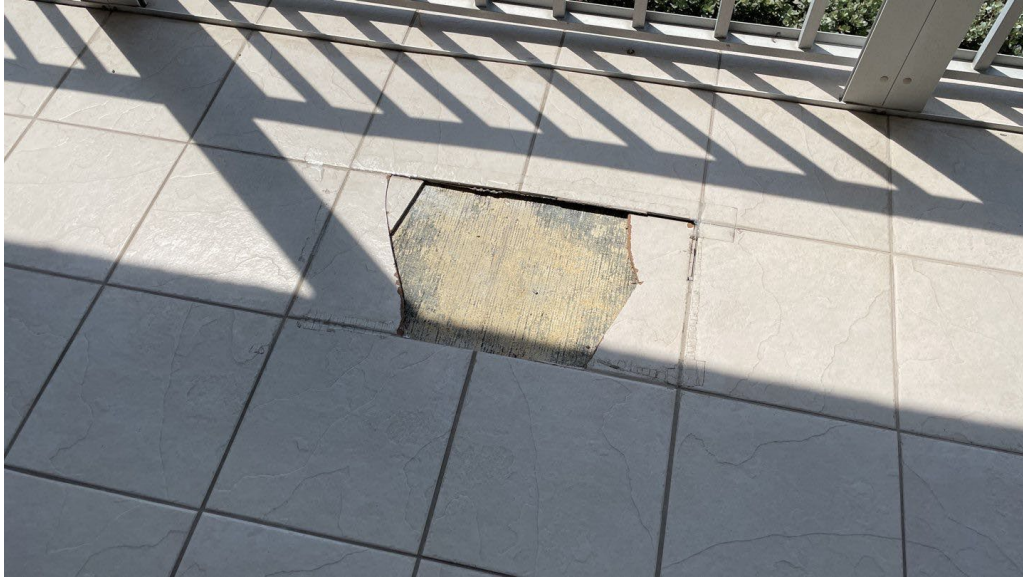
Figure 8

8. Less than 20% of the floor tiles on the balconies were observed and/or detected by sounding to be delaminated on the balconies of Units 101, 102, 103, 200, 308, 312, 502, 503, 505, 512, 700, 701, 800, and 1010. Refer to *Figure 8*.

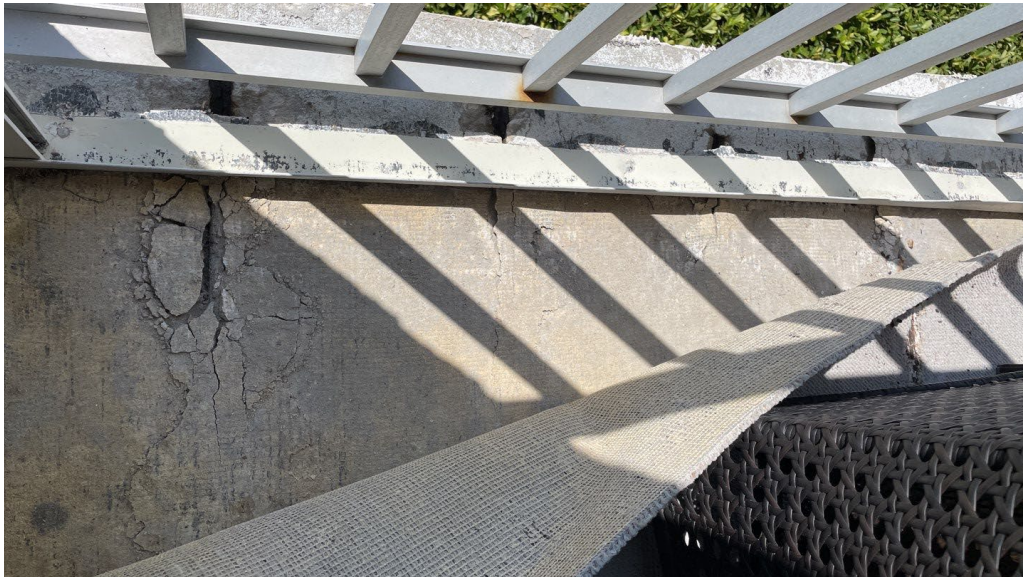
Figure 9

9. Spalling was observed and detected on the horizontal surface of the decks of Units 111, 406, 505, 512, 600, 604, 610, 711, 1010, and P10. An overhead spall was detected on Unit 800. Refer to *Figure 9*.

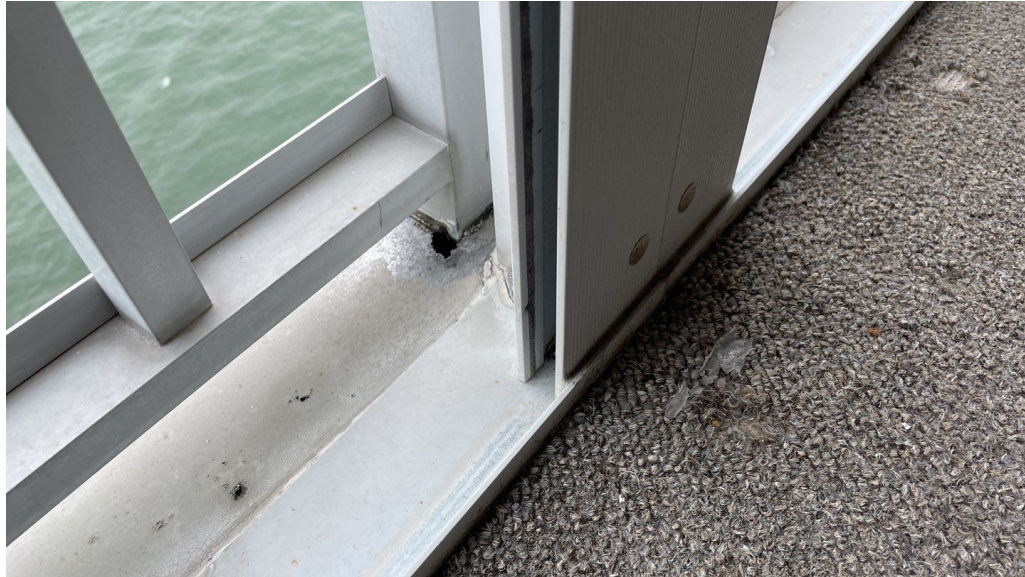
Figure 10

10. Portions of the shutters on the balconies were observed to have been installed in a way that created a dam and inhibited drainage of water off of the balconies. This condition was observed on Units 101, 102, 105, 109, 302, 409, 502, 507, 512, 701, 711, 800, 806, 902, 908, 912, 1004, 1007, 1010. Refer to *Figure 10*.

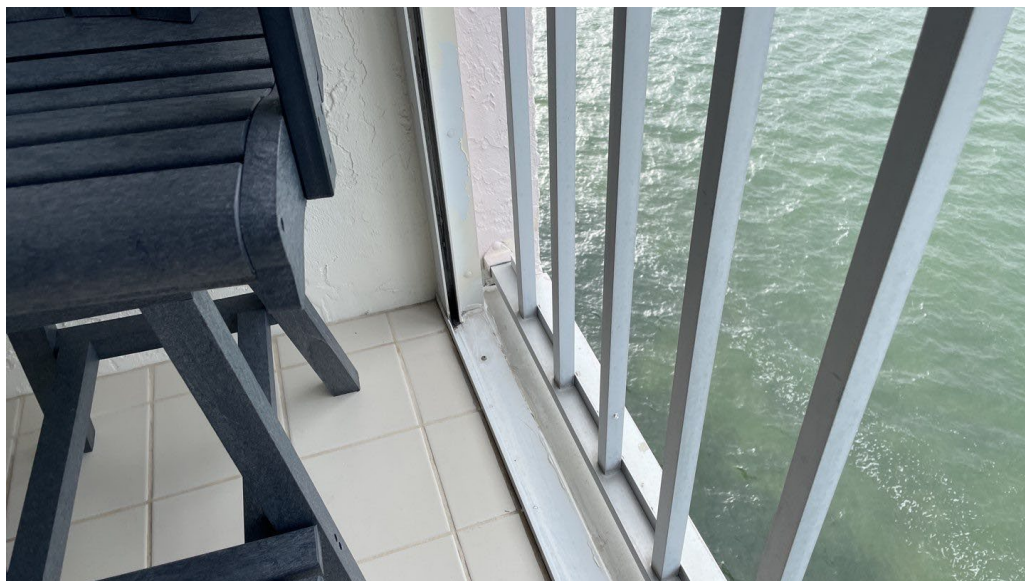
Figure 11

11. The railings of the majority of the units were observed to be original. The railings on Units 206, 505, 512, 800, 902, 907, 908, and 1007 were observed to be loose. Refer to *Figure 11*.

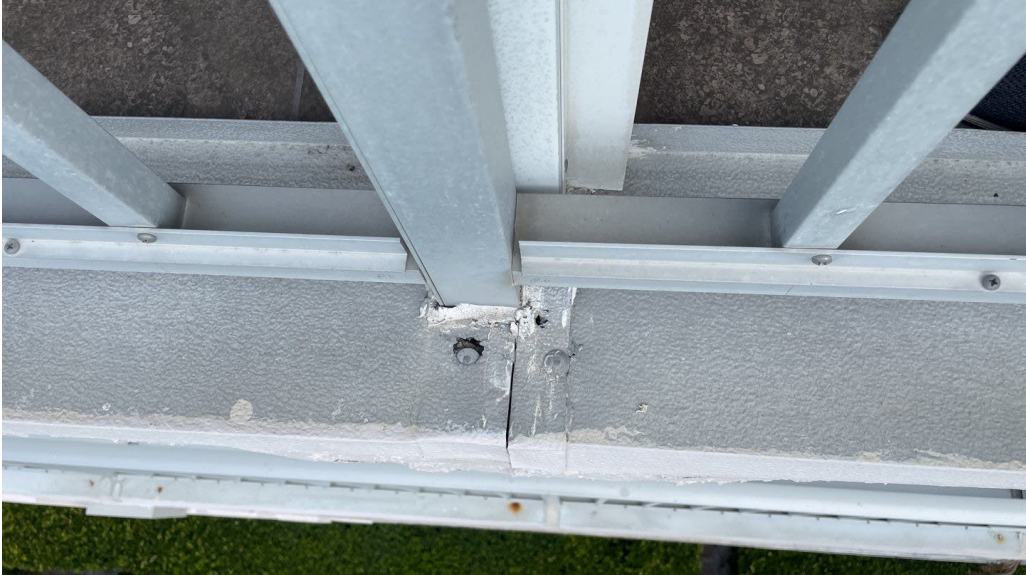
Figure 12

12. Portions of the balconies were observed to have an aluminum drip edge installed along the edge of the balconies. The drip edge appeared to be original and was secured with drive pins. Corrosion was observed in the drip edge around the drive pins in many of the units. This condition would allow for moisture to migrate under the drip edge. Refer to *Figure 12*.

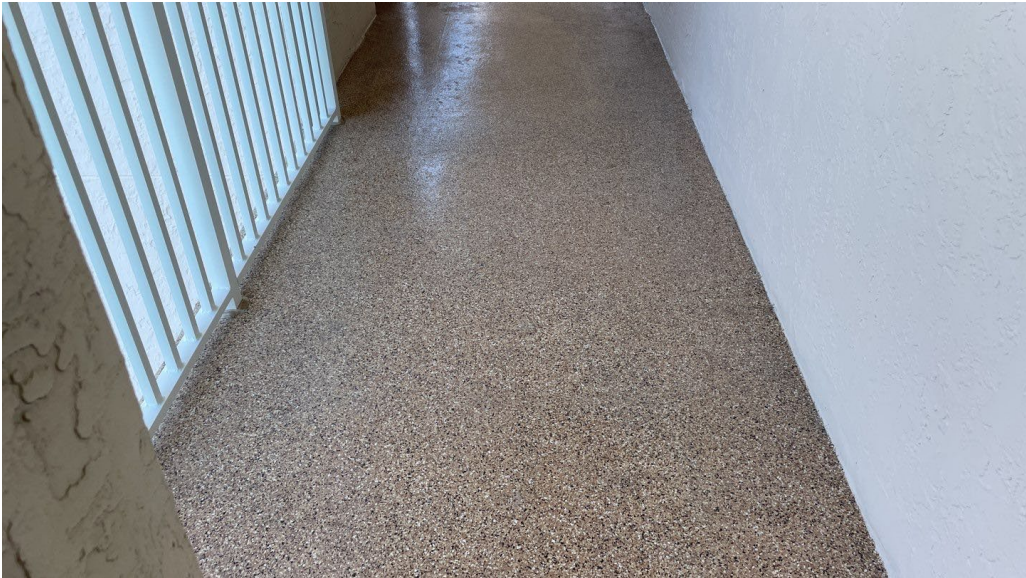
Figure 13

13. The walkways were observed to be coated with a urethane paint flake system. Refer to *Figure 13*.

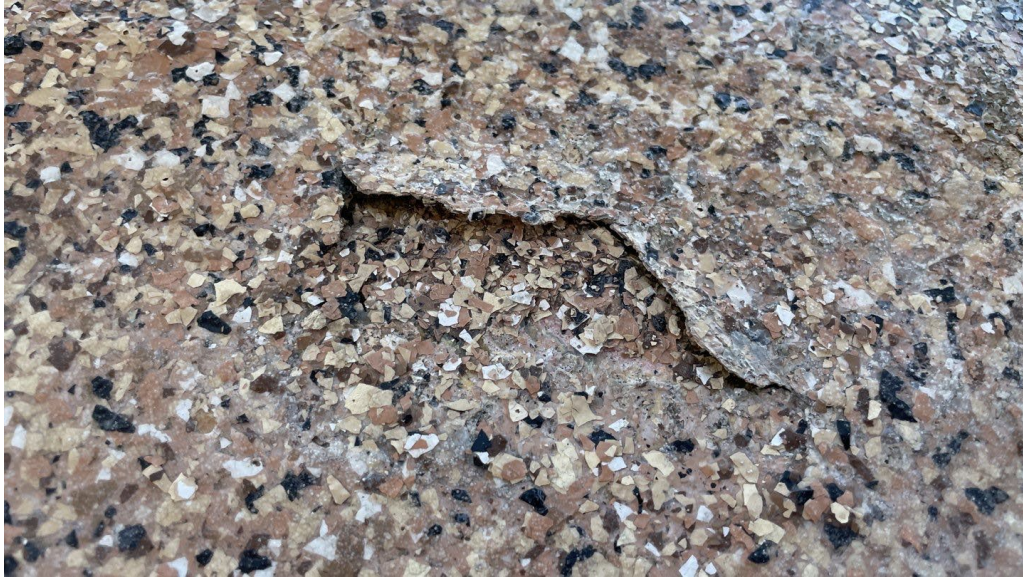
Figure 14

14. Widespread delamination of the coating membrane was observed throughout the walkways with heavy concentrations of delamination along the balcony slab edges. Refer to *Figure 14*.

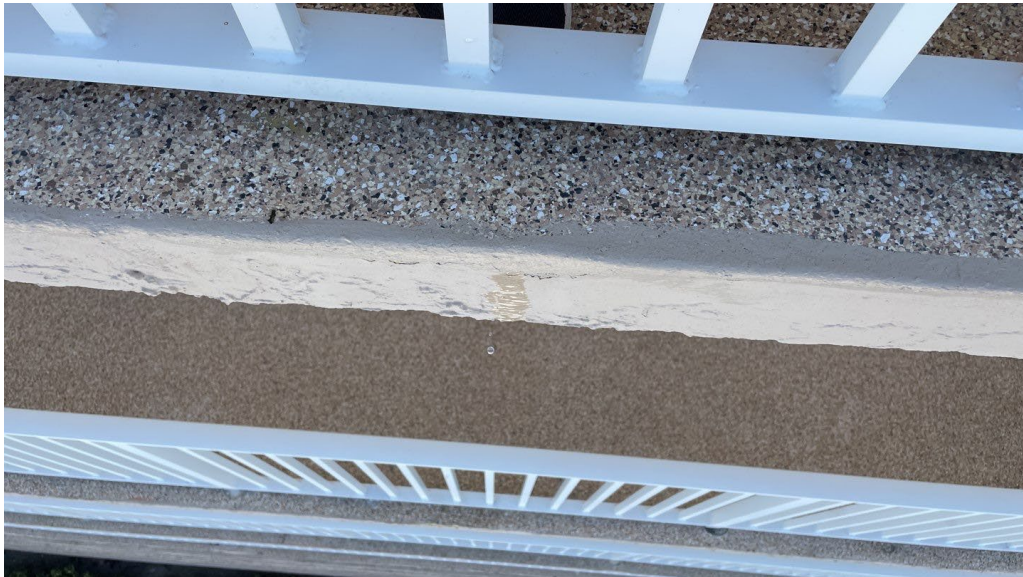
Figure 15

15. The membrane on the walkways was observed to have a fabric installed along the slab edge. The delaminated membrane along the slab edge was observed to be collecting water throughout the walkways. Refer to *Figure 15*.

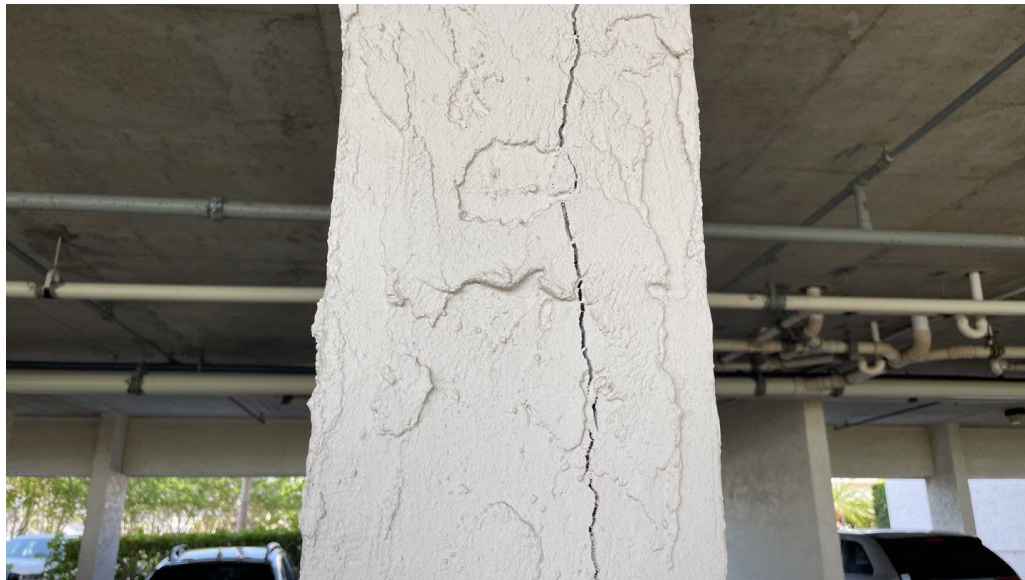
Figure 17

16. Based on sounding, approximately 53 areas of spalling were detected in the surface and along the slab edges of the walkways. The spalling sizes varied from less than 1 square foot up to 18 square feet.
17. The columns and overhead slab in the lower-level parking garage was surveyed and mechanically sounded. Based on the conditions observed 19 columns were observed to have vertical spalling present and two areas of overhead spalling were detected. Refer to *Figure 16* and *Figure 17*.

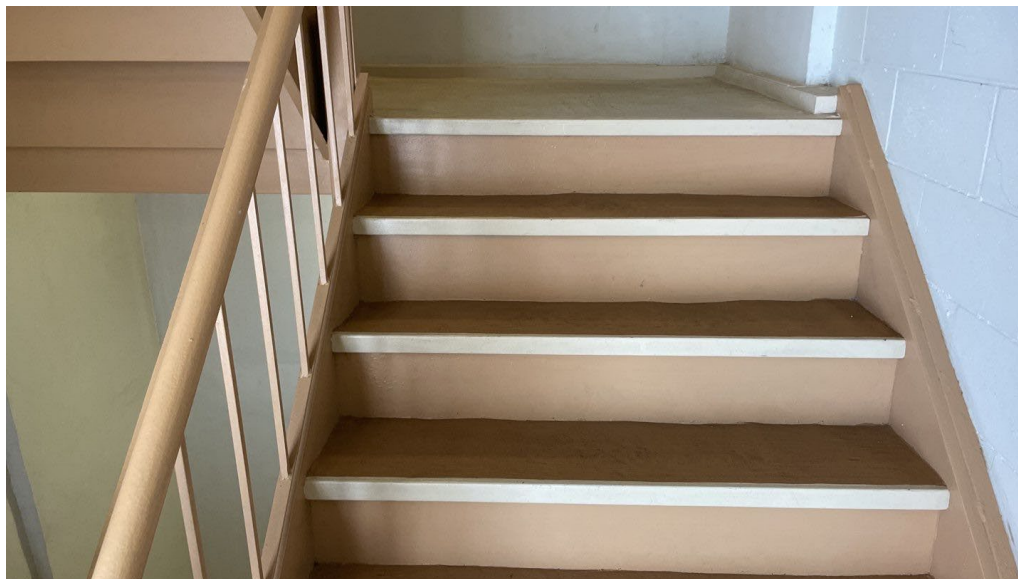
Figure 19

18. The stairs in the tower were observed to consist of steel framed stairs with concrete toppings. No areas of corrosion or spalling were observed on the stairs. Refer to *Figure 19*.
