## COMMERCIAL WINDSTORM MITIGATION REPORT (OIR-B1-1802)

Town Shores of Gulfport, No. 218 - Buckingham

6060 Shore Blvd S, Buckingham Building, Units 100-1012, PH1-10

As of 3/15/2021

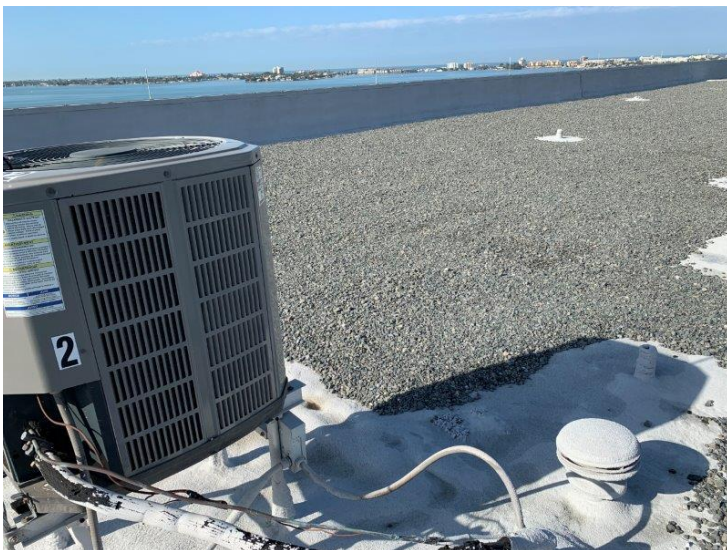
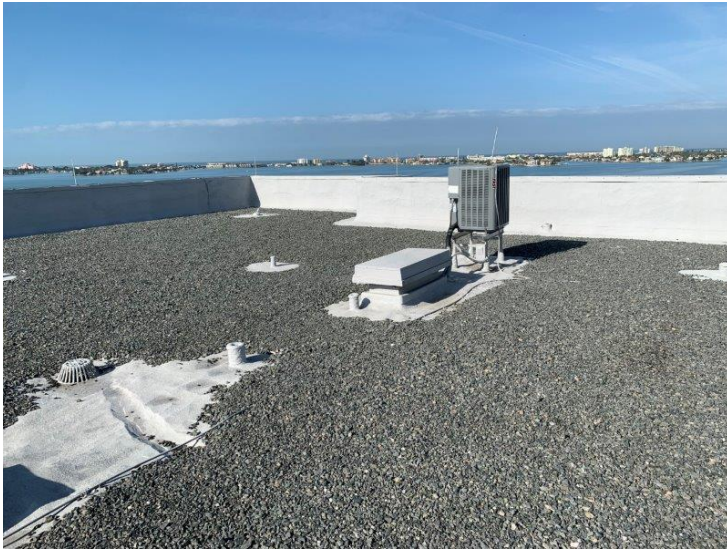
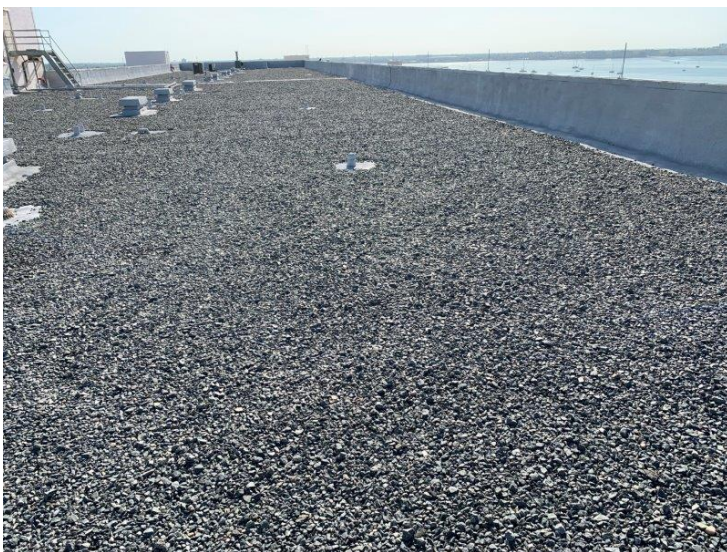
Roof Construction

| <b>3. <u>Roof Deck Attachment:</u></b><br>Comments: | <b>Reinforced Concrete Roof Deck</b><br>Inspection verified a roof structure composed of cast-in-place or pre-cast structural concrete designed to be self-supporting and integrally attached to the wall / support system. |
| <b>4. <u>Roof to Wall Attachment:</u></b><br>Comments: | <b>Structural</b><br>Inspection verified a roof structure composed of cast-in-place or pre-cast structural concrete designed to be self-supporting and integrally attached to the wall / support system. |
| <b>5. <u>Roof Geometry:</u></b><br>Comments: | <b>Flat Roof</b><br>Inspection verified flat roof shape, refer to attached photographs. |
