Windstorm Mitigation Report

Town Shores of Gulfport No 211, Jamison Building

Windstorm Mitigation Report (OIR-B1-1802)

Windstorm Mitigation Report (MIT-BT II & III)

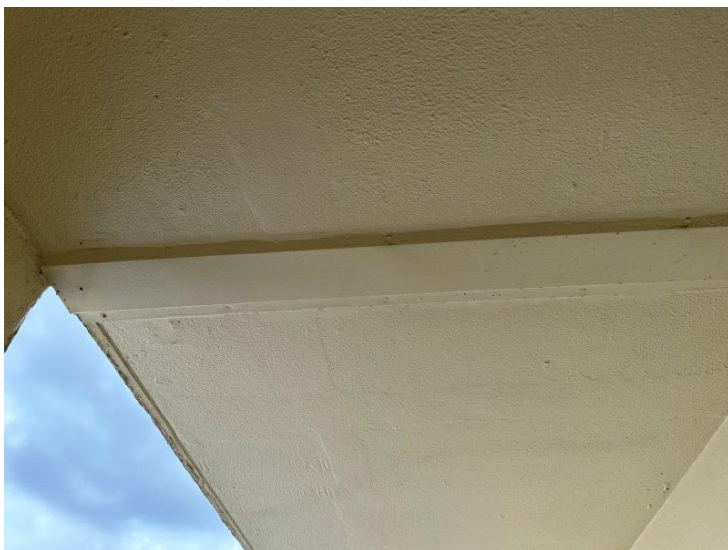
Roof Permit
Information
Roof Construction

- 2. Roof Covering:** **FBC Equivalent**
Comments: The roof covering was replaced in 2019. The roof permit was confirmed and the permit number is BLDC201902771. This roof was verified as meeting the building code requirements outlined on the mitigation affidavit.

BUDC20190271	ROOF	27 Dec 2019	\$34,780
--------------	------	-------------	----------

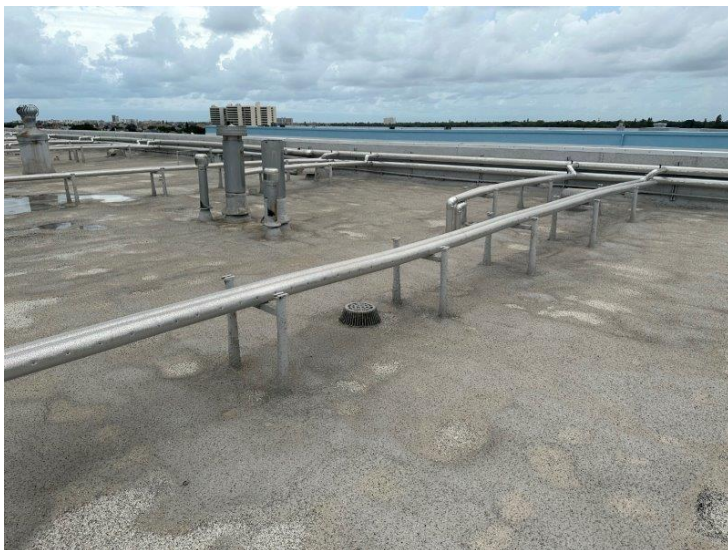
Roof Construction

- 3. Roof Deck Attachment:** **Reinforced Concrete Roof Deck**
Comments: Inspection verified a roof structure composed of cast-in-place or pre-cast structural concrete designed to be self-supporting and integrally attached to the wall / support system.

- 5. Roof Geometry:** **Flat Roof**
Comments: Inspection verified flat roof shape, refer to attached photographs.
- 6. SWR:** **No**
Comments: SWR does not apply to reinforced concrete roof decks.

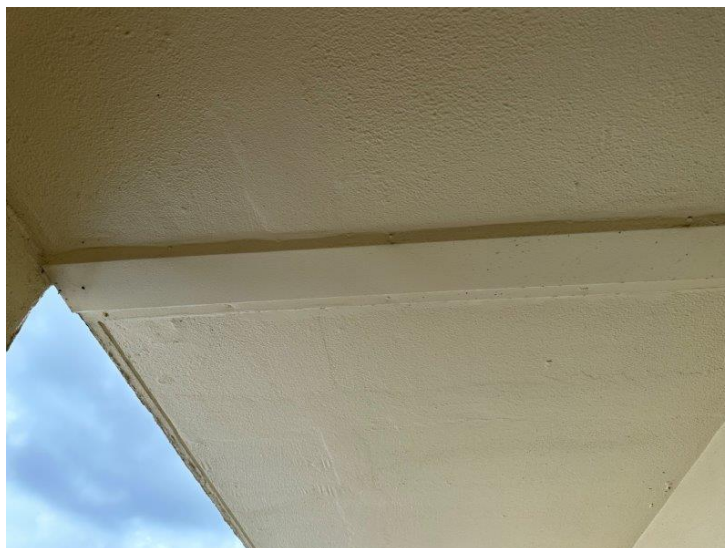
Roof Permit Information
Roof Construction

- 1. Roof Covering:** **FBC Equivalent**
Comments: The roof covering was replaced in 2019. The roof permit was confirmed and the permit number is BLDC201902771. This roof was verified as meeting the building code requirements outlined on the mitigation affidavit.
- 2. Roof Deck Attachment:** **Reinforced Concrete Roof Deck**
Comments: Inspection verified a roof structure composed of cast-in-place or pre-cast structural concrete designed to be self-supporting and integrally attached to the wall / support system.
- 3. SWR:** **No**
Comments: SWR does not apply to reinforced concrete roof decks.
- 4. Opening Protection:** **None or Some Glazed Openings**
Comments: Inspection verified some impact rated opening protection. Not all glazed openings were protected with impact resistant coverings.

B.L.D.C.201902771	ROOF	27 Dec 2019	\$244,780
-------------------	------	-------------	-----------
