Windstorm Mitigation Report

Town Shores of Gulfport, No. 212 (Diplomat)

Gulfport, FL

As of 6/22/2022 | FPAT File# MUD2217704

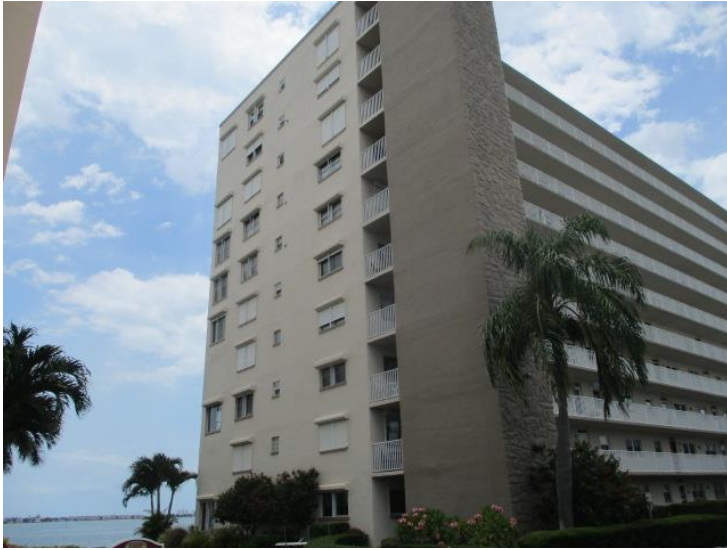
Exterior Elevation

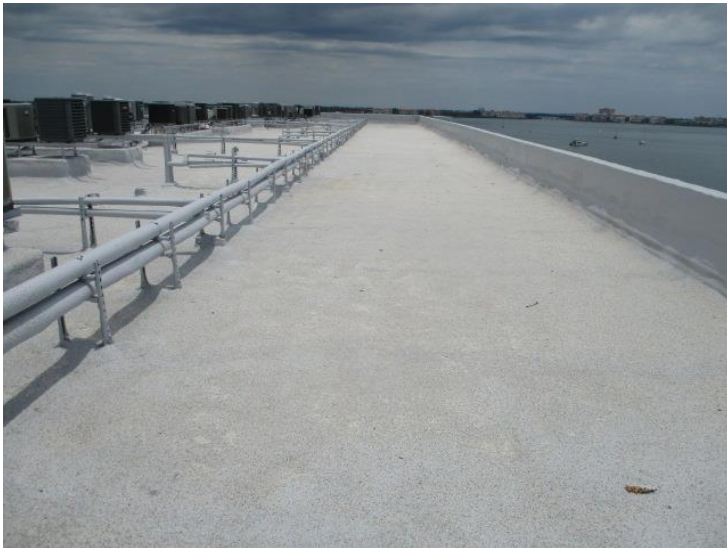
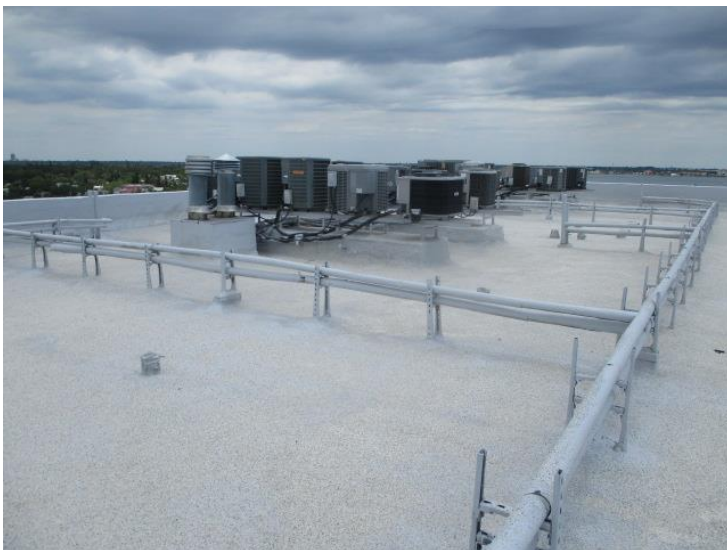
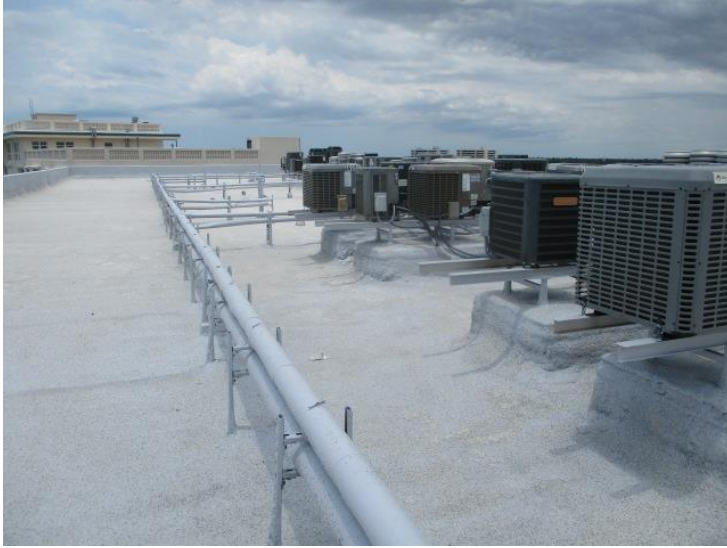
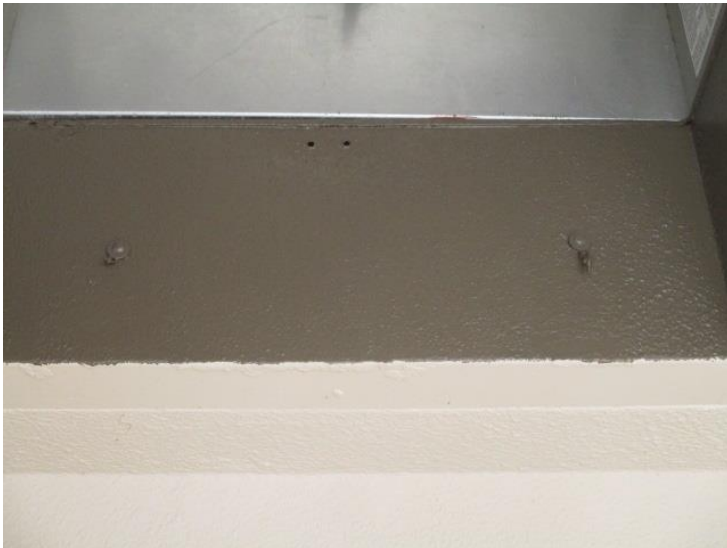
- 3. Roof Deck Attachment:** **Reinforced Concrete Roof Deck**
Comments: Inspection verified a roof structure composed of cast-in-place or pre-cast structural concrete designed to be self-supporting and integrally attached to the wall / support system.

- 4. Roof to Wall Attachment:** **Structural**
Comments: Inspection verified a roof structure composed of cast-in-place or pre-cast structural concrete designed to be self-supporting and integrally attached to the wall / support system.

- 5. Roof Geometry:** **Flat Roof**
Comments: Inspection verified flat roof shape, refer to attached photographs.
- 6. SWR:** **No**
Comments: SWR does not apply to reinforced concrete roof decks.

Roof Construction

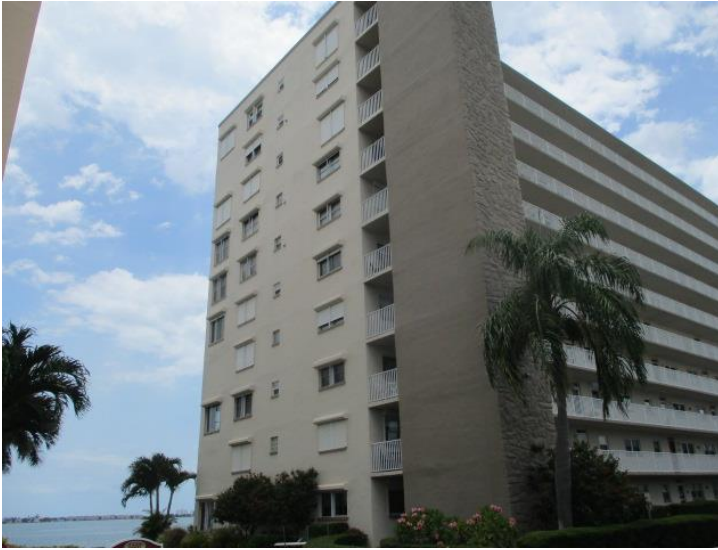
Exterior Elevation

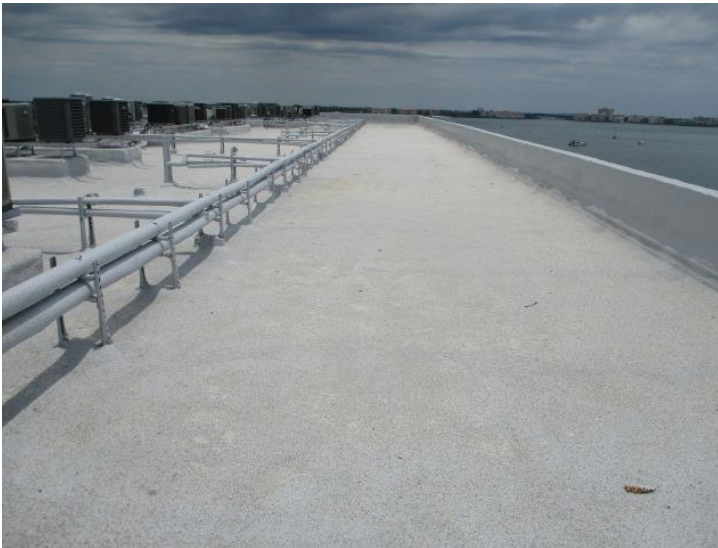
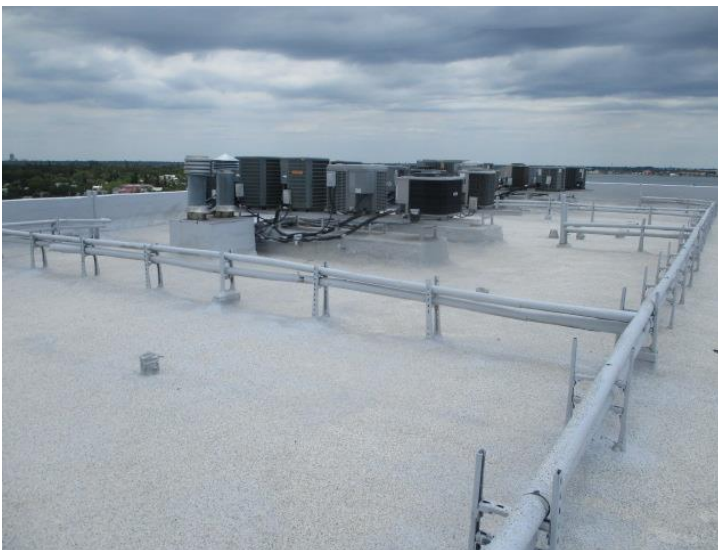
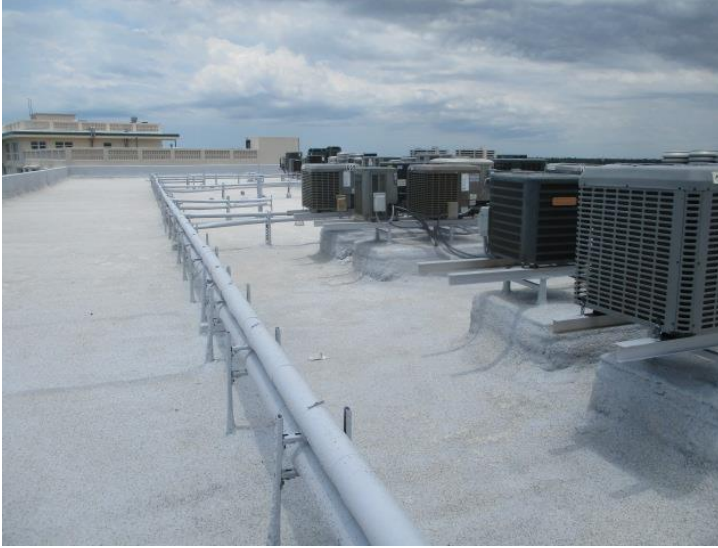
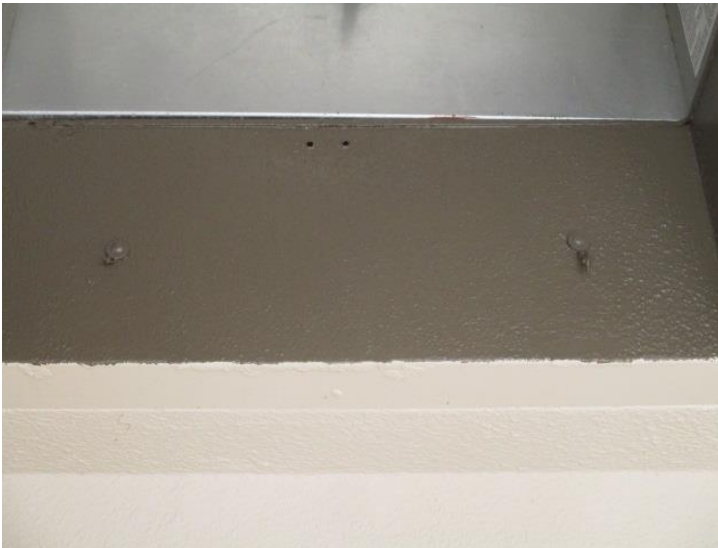
- 1. Roof Covering:** **FBC Equivalent**
Comments: The roof covering was replaced in 2022. The roof permit was confirmed and the permit number is BLDR202200155. This roof was verified as meeting the building code requirements outlined on the mitigation affidavit.
- 2. Roof Deck Attachment:** **Reinforced Concrete Roof Deck**
Comments: Inspection verified a roof structure composed of cast-in-place or pre-cast structural concrete designed to be self-supporting and integrally attached to the wall / support system.
- 3. SWR:** **No**
Comments: SWR does not apply to reinforced concrete roof decks.
- 4. Opening Protection:** **None or Some Glazed Openings**
Comments: Inspection verified some metal shutter opening protection. Not all glazed openings were protected with impact resistant coverings.

Roof Construction
