Windstorm Mitigation Report (OIR-B1-1802)

Town Shores of Gulfport, No. 217 - Windsor
6020 Shore Blvd S, Windsor Building, Units 101-1012, PH1-PH2
Gulfport, FL 33707

Prepared Exclusively for Town Shores of Gulfport, No. 217, Inc., A Condominium

As of 3/15/2021 | FPAT File# MIT2115735

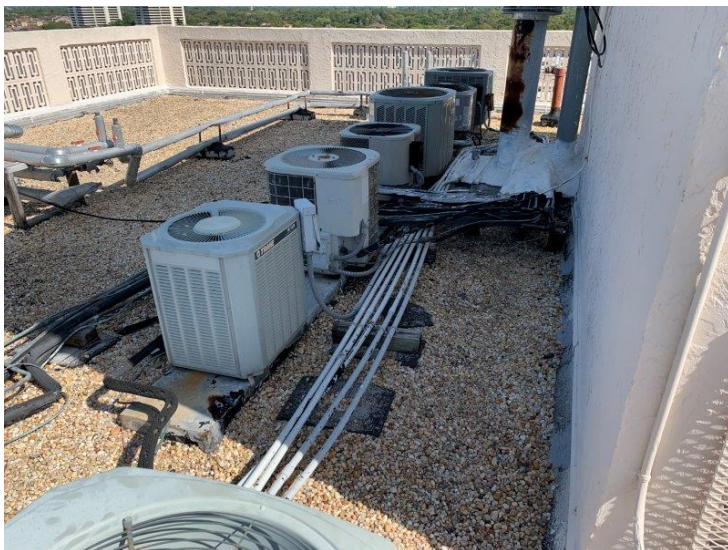
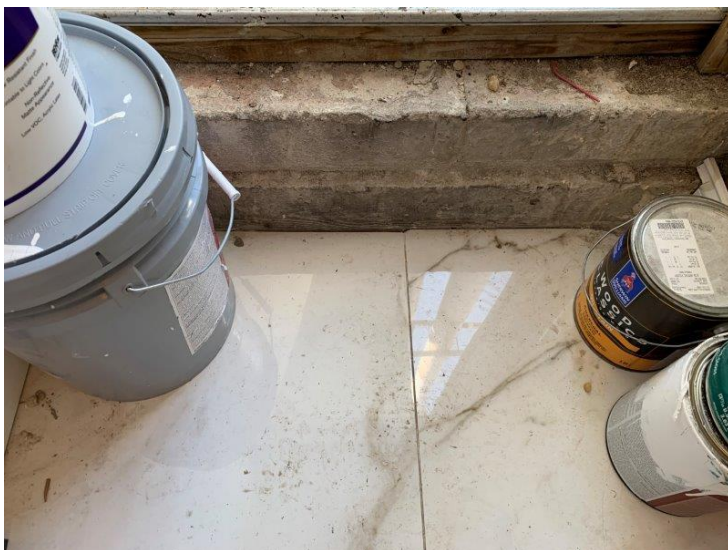
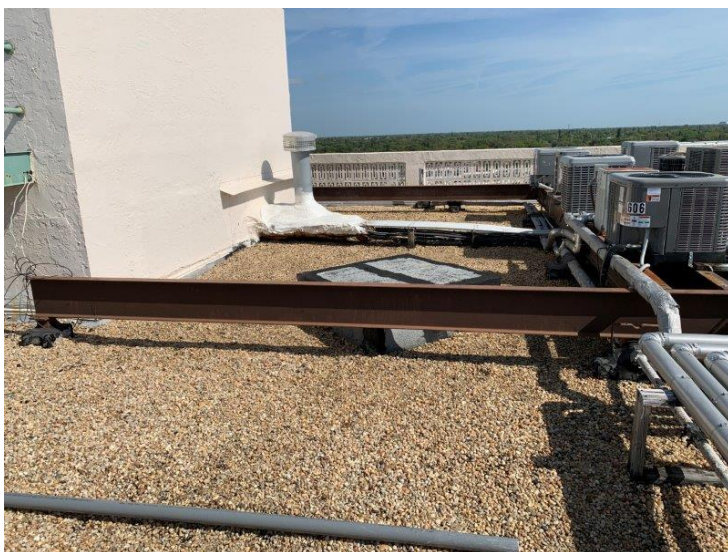
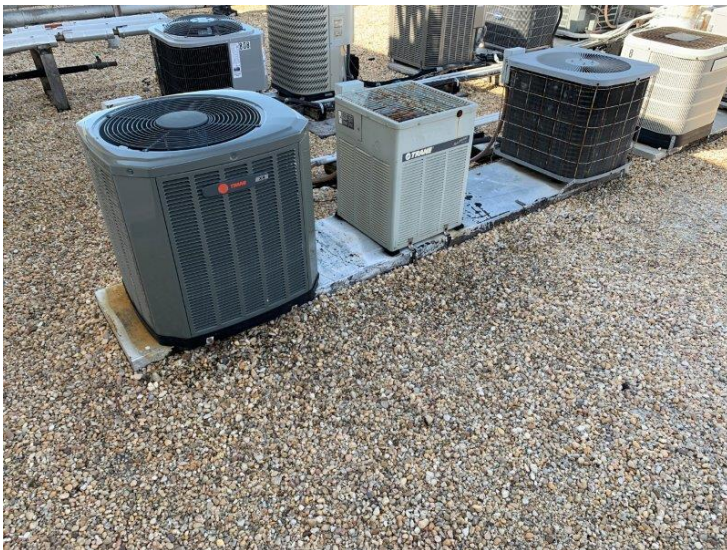
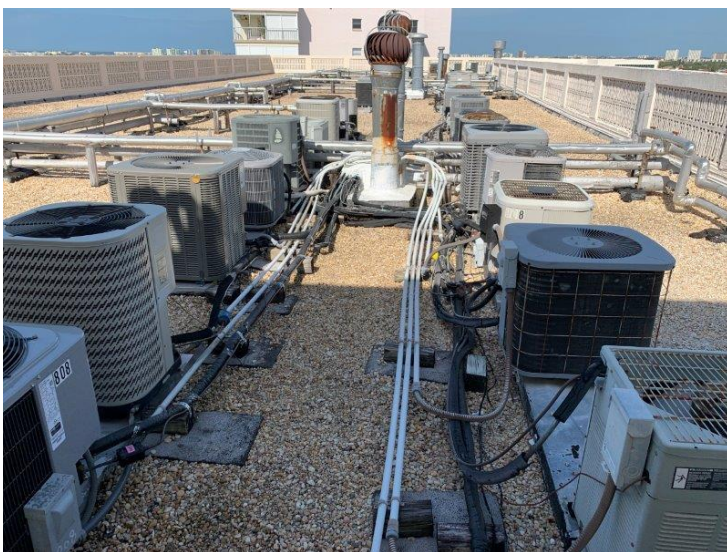
Roof Construction

Comments: | Reinforced Concrete Roof Deck
Inspection verified a roof structure composed of cast-in-place or pre-cast structural concrete designed to be self-supporting and integrally attached to the wall / support system. |

Comments: | Structural
Inspection verified a roof structure composed of cast-in-place or pre-cast structural concrete designed to be self-supporting and integrally attached to the wall / support system. |

Comments: | Flat Roof
Inspection verified flat roof shape, refer to attached photographs. |
