THIS MILESTONE PHASE 1 INSPECTION REPORT WAS PRODUCED FOR THE 10-STORY BUILDING OF TOWN SHORES OF GULFPORT NO. 212, INC. DIPLOMAT CONDOMINIUM LOCATED AT 5980 SHORE BLVD. S., GULFPORT, FL 33707.

DIPLOMAT HOUSE

MILESTONE PHASE 1 INSPECTION SURVEY

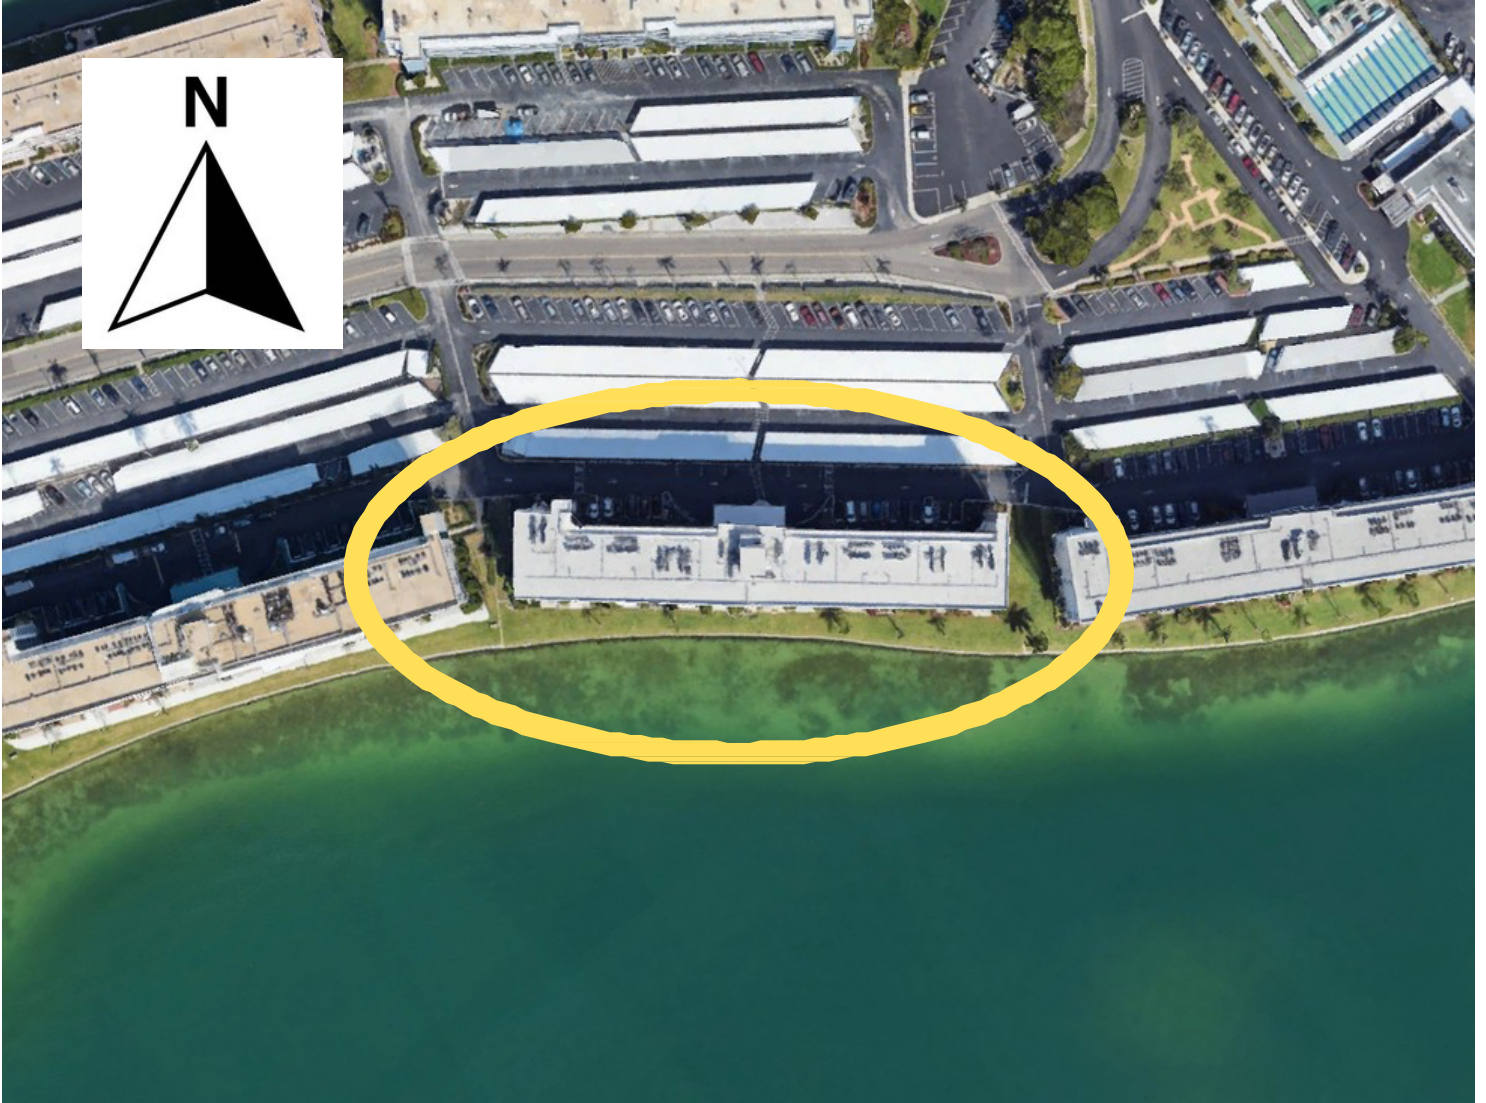
Plan view (overhead) image of the Diplomat House building at Town Shores of Gulfport.

Photos showing the layout of the building are provided on the following pages.

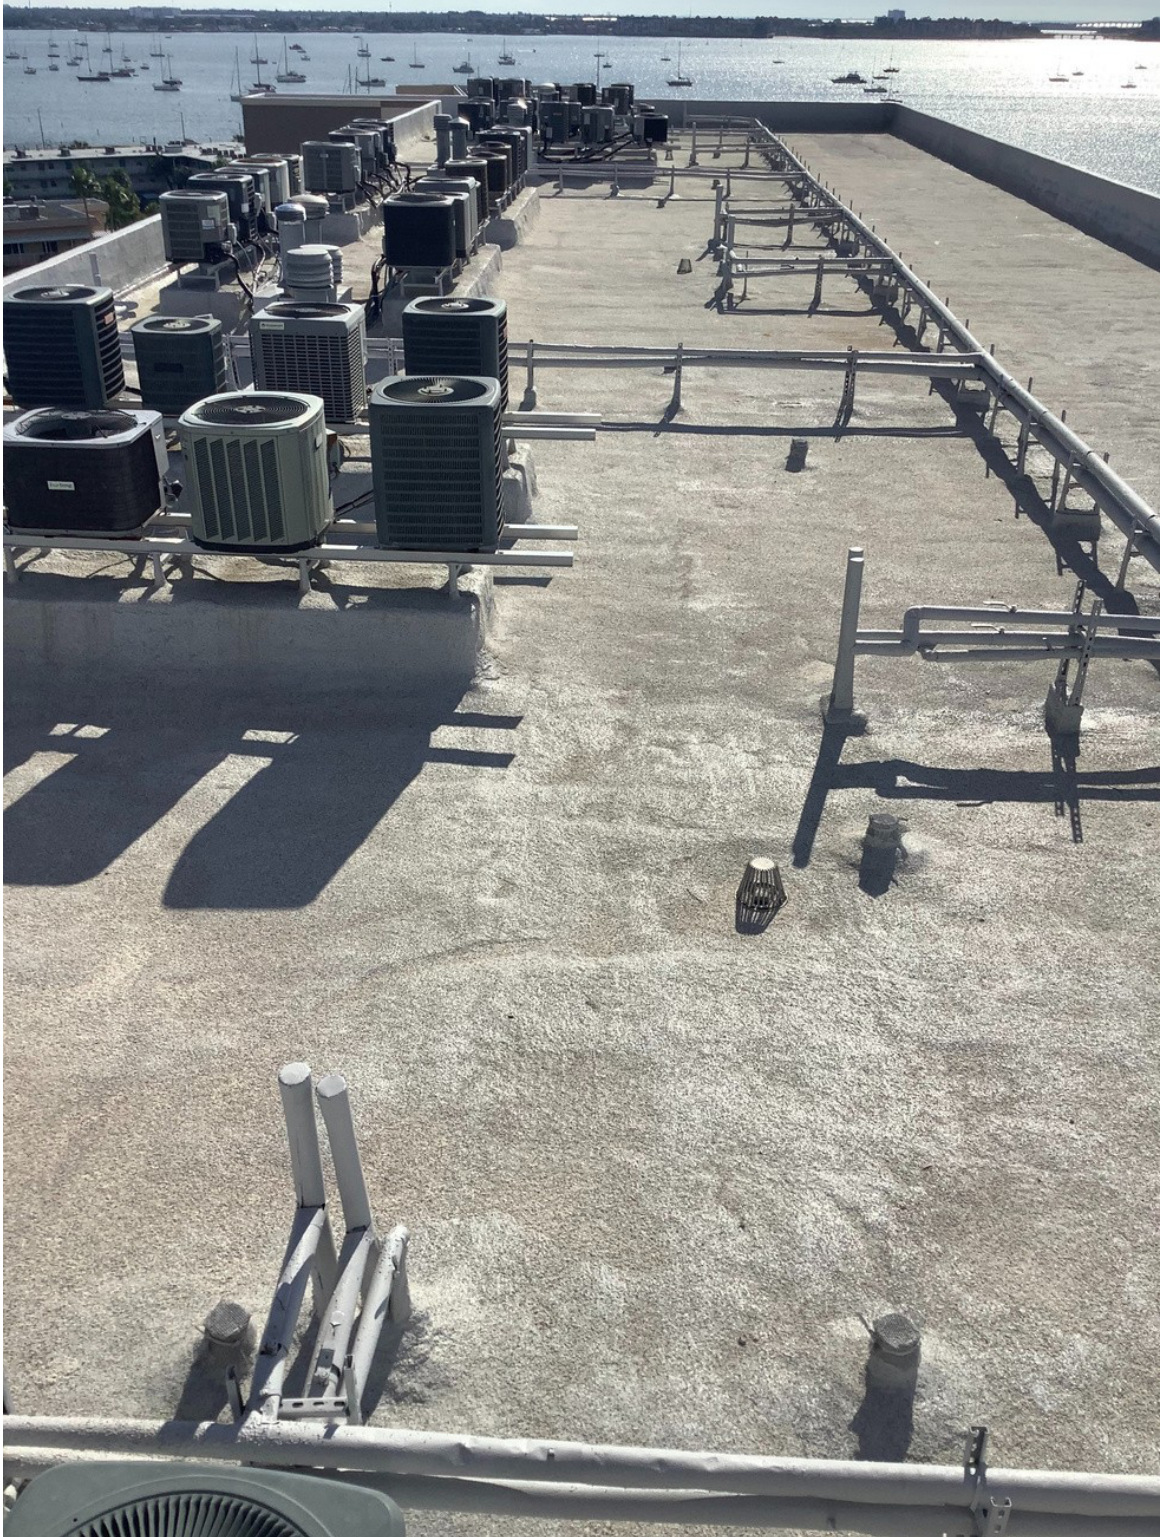
**Diplomat House building at Town Shores of Gulfport.
Typical Roof & elevation captured 11/18/2022.**
